Ministry of  
Transportation  
and Infrastructure

# Texada Island Drainage Study

Final Report

January 2024

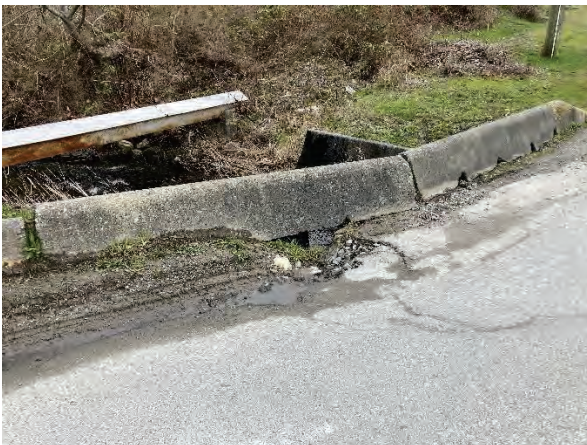
- Prior high flow events led to a smaller road embankment failure (see [Photo 1](#)).
- The culvert crossing has been identified, as being potentially undersized, as it operates frequently at full capacity (see [Photo 2](#)).
- The Van Anda Improvement District (VID) noted that a previous maintenance attempt of the culvert had to be abandoned, due to concerns of the failure of the culvert from the maintenance works.

PHOTO 1: AREA 1 - ROAD EMBANKMENT FAILURE (MOTI, MARCH 2022)

2	<b>Culvert Replacement - Van Anda Creek @ Van Anda Avenue</b> (Priority Area 1)	2257630, 2257631	<ul style="list-style-type: none"> <li>Existing twin 900 mm CSP culvert pipes are in poor condition and undersized for the design storm requiring a replacement.</li> <li>The critical condition of the culvert is highlighted, as a previous maintenance attempt had to be halted, due to concerns that the culvert could potentially fail during the works.</li> <li>The replacement culvert was conceptually sized to be a 4,800 x 1,600 mm open-bottom arch culvert with fish gravels for fish passage. The replacement includes headwalls and wingwalls. <ul style="list-style-type: none"> <li>The replacement culvert requires a regrading and raise of the Van Anda Avenue crossing.</li> </ul> </li> </ul>
3	<b>Erosion Protection of Staaf Creek @ Bell Road</b> (Priority Area 6)	NA	<ul style="list-style-type: none"> <li>Install Class 100kg Riprap along the right bank of Staaf Creek next to Bell Road just upstream of the ex. culvert crossing (2254782) and regrade the creek embankment to 2:1 on a length of 50 metres.</li> </ul>

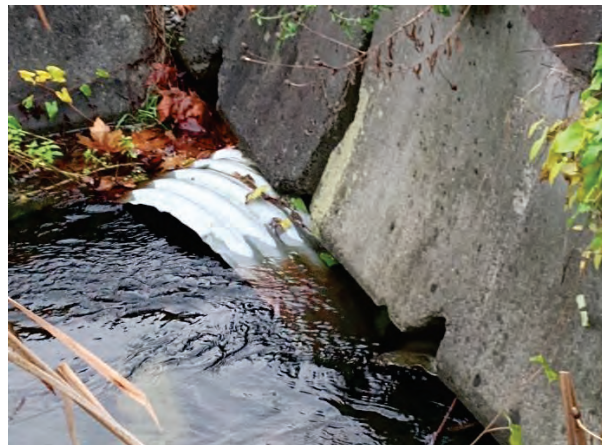
PHOTO 2: AREA 1- FULL FLOW (VID, NOVEMBER 2023)

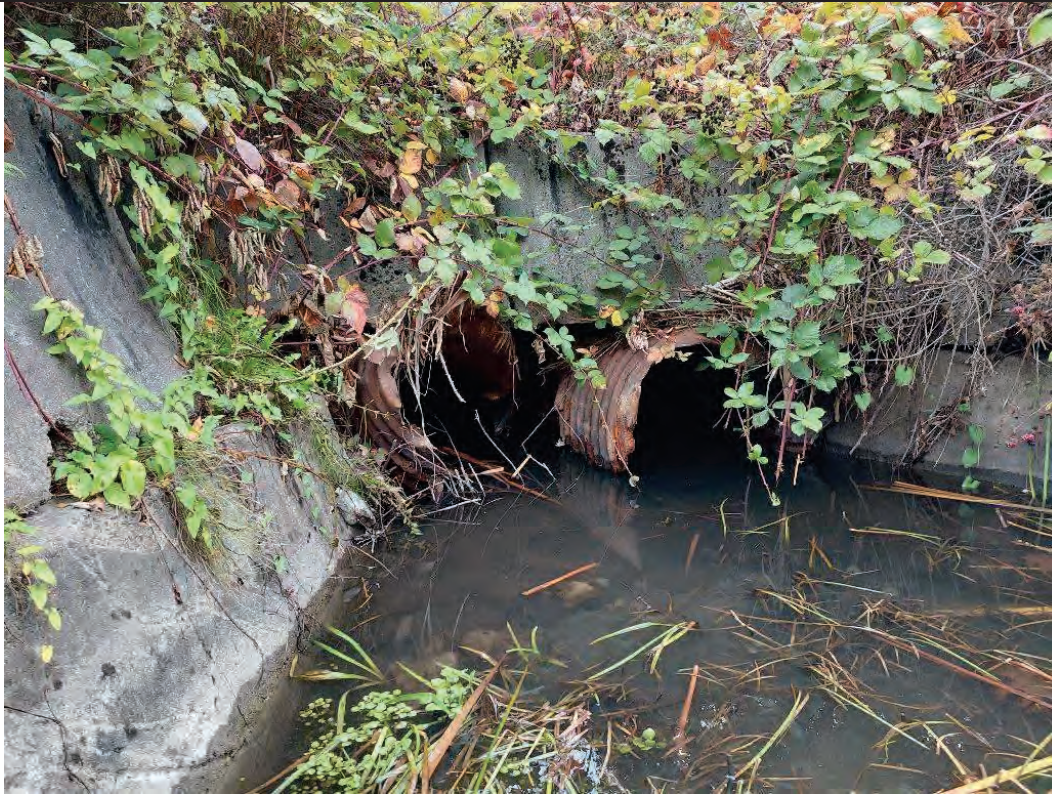
- Twin 900 mm CSP culvert (CHRIS: 2257630 & 2257631, “Culvert 2”) with improvised headwalls and wingwalls at the inlet and outlet from concrete roadside barriers (CRBs).
- Both culvert pipes appeared to be heavily corroded with damaged inlets.
- The lack of a proper headwall led to scour at the inlet between both pipes with the potential for piping.
- The CRBs were placed directly on top of the unprotected pipes creating an uneven load.
- Sediment and vegetation at the outlet blocked about 25% of the overgrown downstream channel.
- Tension cracks are visible on the pavement above along both sides of the culvert crossing indicating settlement and potential piping.
- The culvert pipes appeared to be overall in poor condition and are recommended to be replaced.
- The culvert crossing is signed as fish-bearing.

Culvert Inlet: Inlet damaged and corroded, CRB headwall & wingwalls

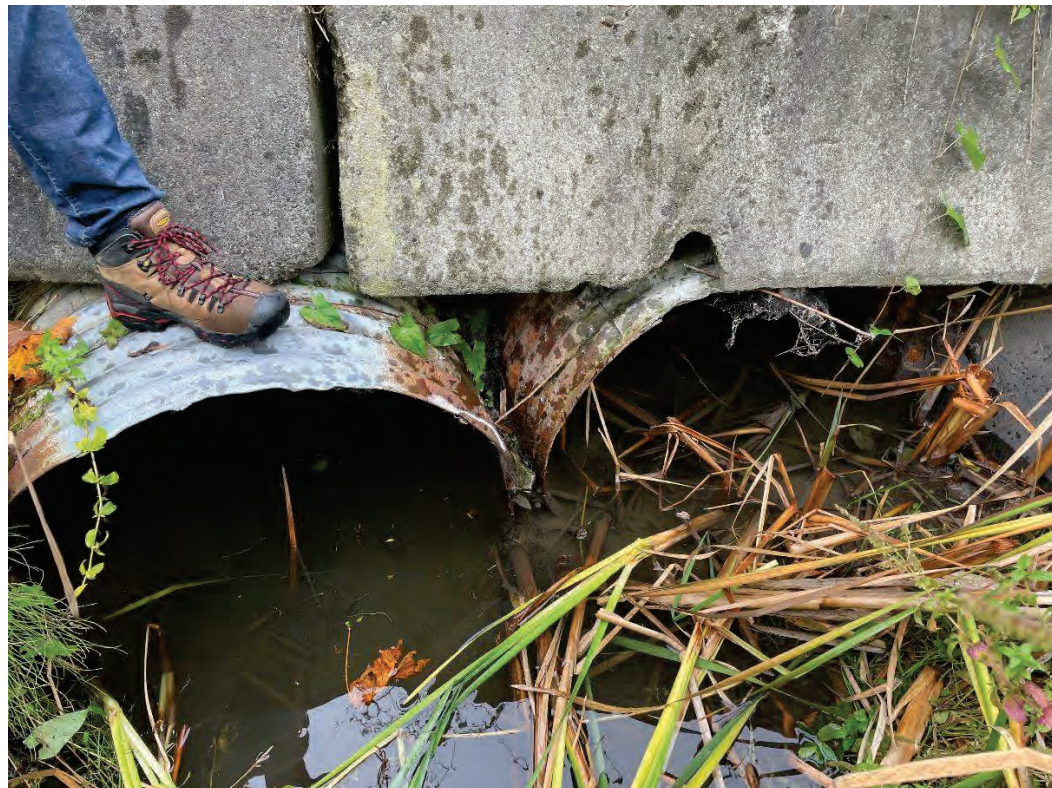
Culvert Outlet: Sediment Accumulation on right bank

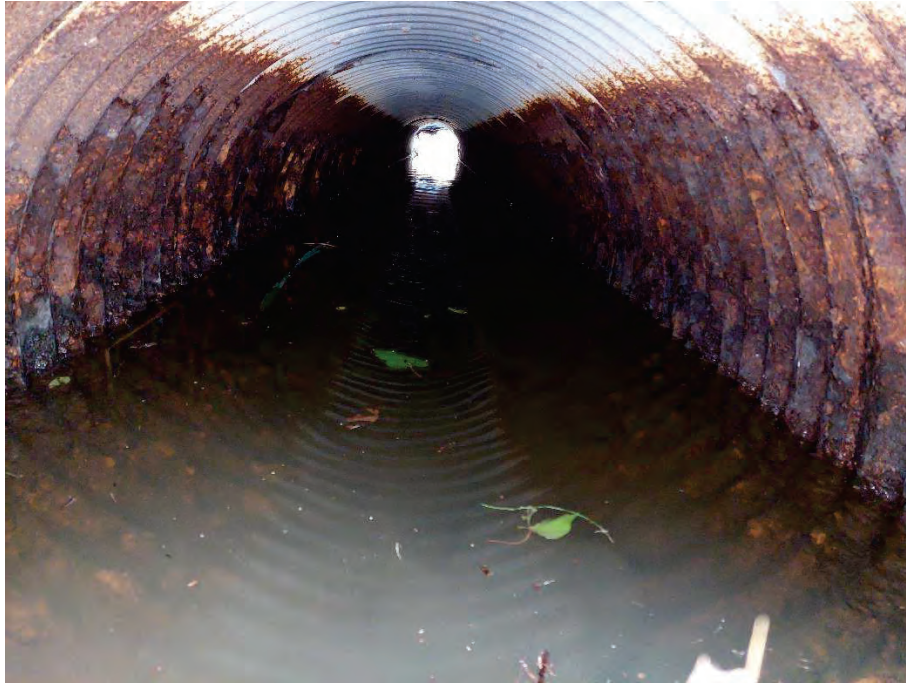
Pipe Interior (eastern pipe) facing US: Signs of significant corrosion with loss of material visible, 2 to 11 o'clock

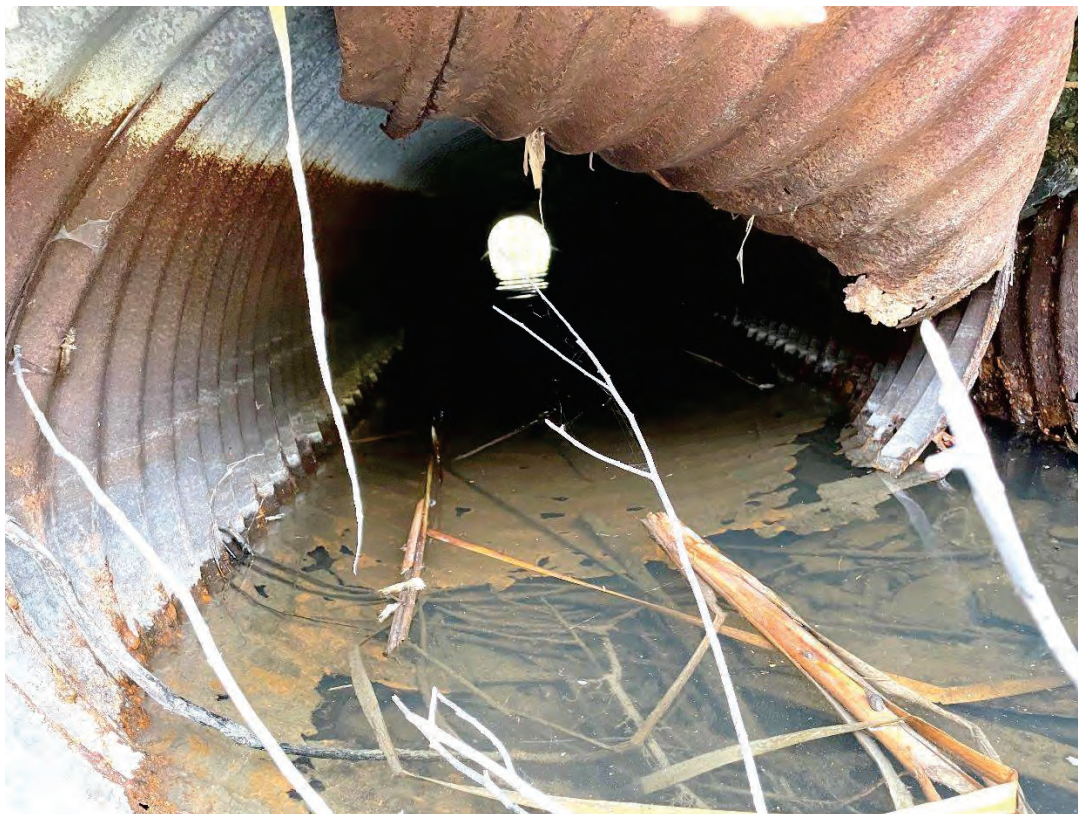
Pipe Interior (western pipe) facing DS: Visible damage of inlet and heavy corrosion of invert

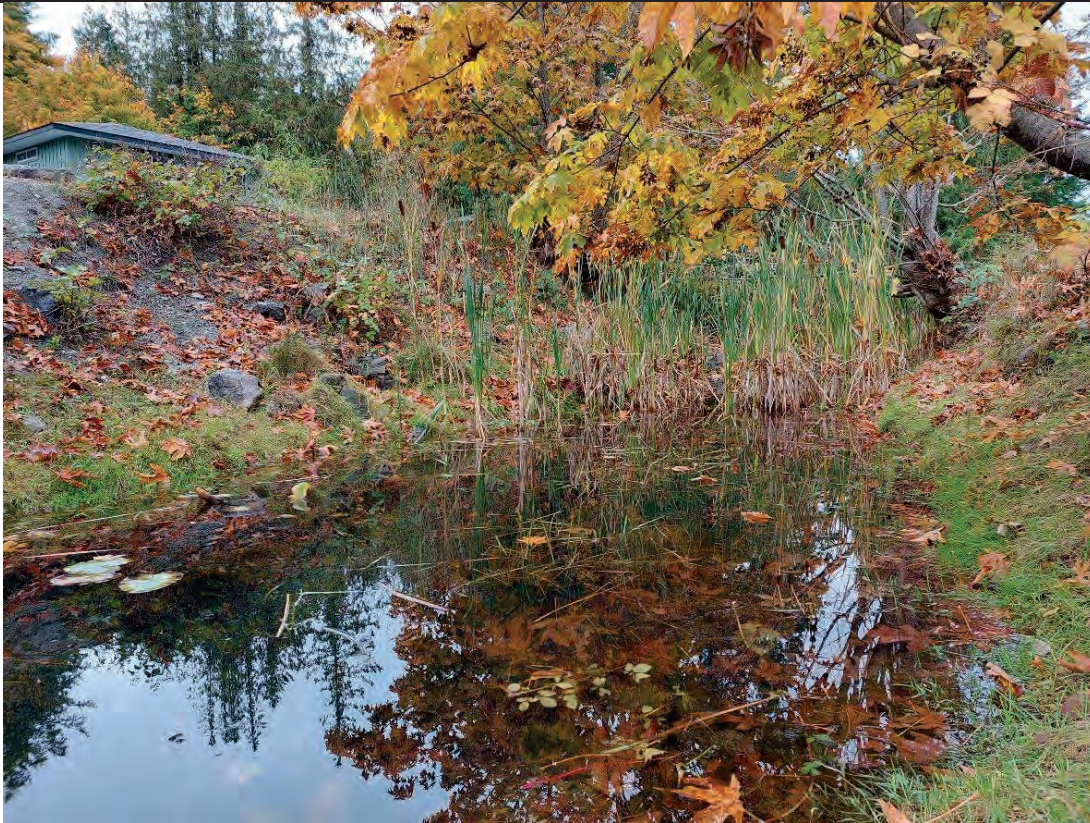
Upstream Channel facing US: Bank erosion visible on the left side

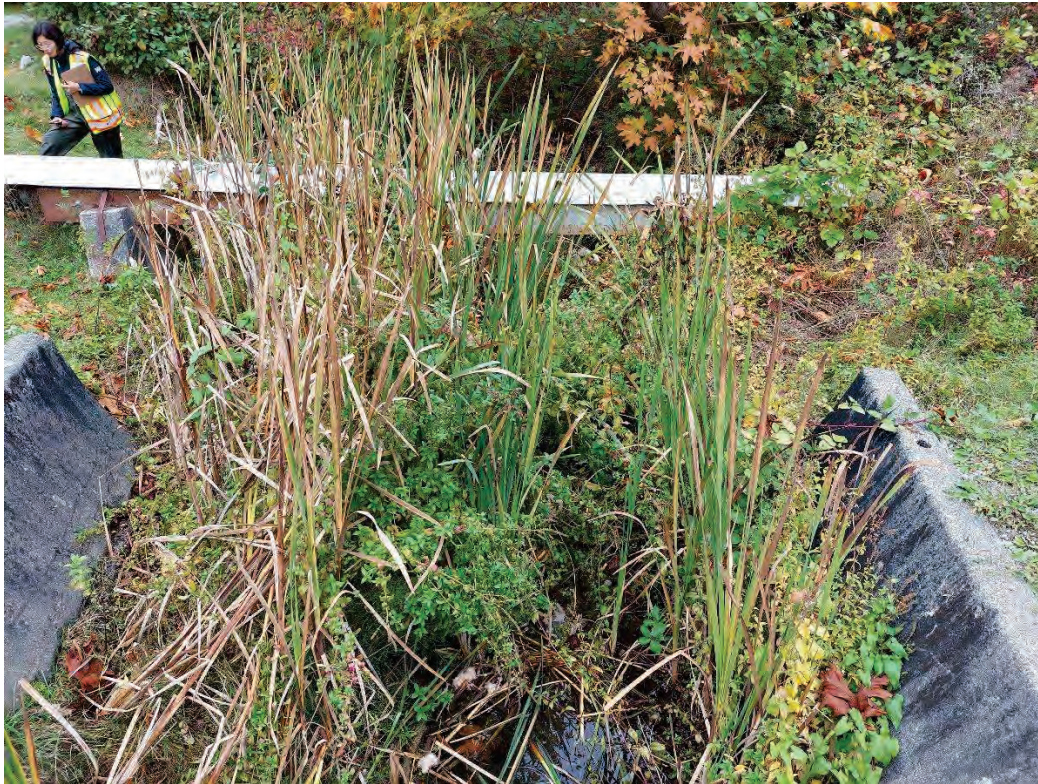
Downstream Channel facing DS: Sediment accumulation and vegetation visible & CRB wingwalls

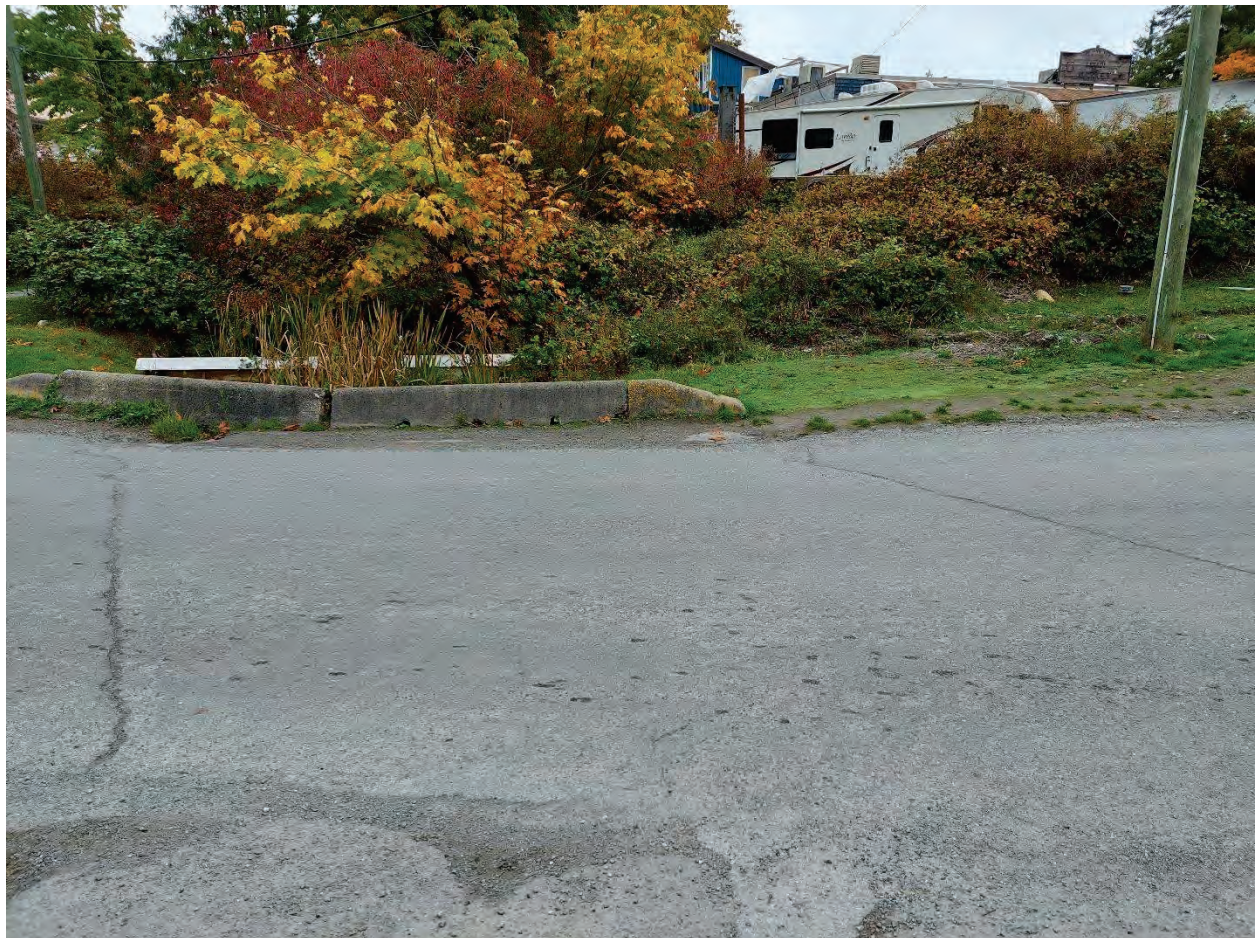
Pavement Surface: Tension cracks visible on the left and the right from the culvert crossing

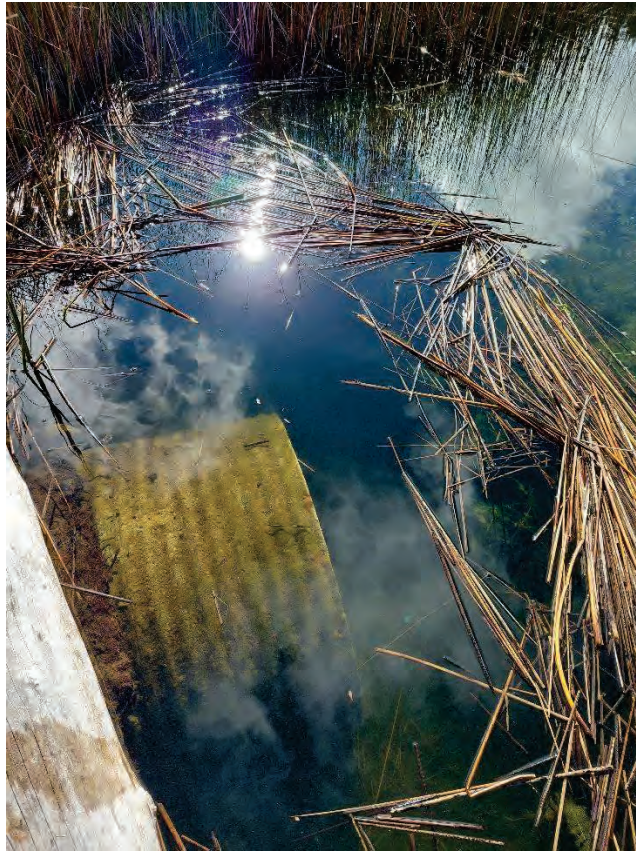
- A single 1200 mm CSP culvert (CHRIS: 3442936, “Culvert 3”) was found connecting Priest Lake with a downstream pond and Van Anda Creek.
- The culvert crossed both the gravel Priest Lake Road and the paved Gillies Bay Road.
- The culvert was completely submerged at the inlet and 75% full at the outlet during the inspection, with no apparent flow through the culvert. The perceived water level difference between inlet and outlet suggests a potential blockage of the culvert. Large woody debris and reeds were present at the upstream and downstream.

Culvert Inlet: Inlet fully submerged, log and reeds debris present above pipe

#	RECOMMENDATION	CHRIS ID	RECOMMENDATION NOTES
<b>SHORT-TERM RECOMMENDATIONS (within next 2 years)</b>			
1	<b>Maintenance, Inspection &amp; Blockage Removal at Priest Lake</b> (Priority Area 3)	344936	<ul style="list-style-type: none"> <li>Existing 1,200 mm CSP culvert is likely blocked and has no relief structure with risk of overflowing and flooding of Gillies Bay Road.</li> <li>Based on observations from site assessment and Van Anda Improvement District comments that the downstream water level is lower than the upstream water level without apparent flow indicating a potential blockage of the culvert.</li> <li>Similar to previous maintenance, a specialized maintenance crew will be required as the culvert will likely be submerged due to the high downstream water level from the Priest Lake weir downstream of the pond.</li> <li>Note that Priest Lake is an active water reservoir, and the downstream pond is a sensitive habitat.</li> </ul>

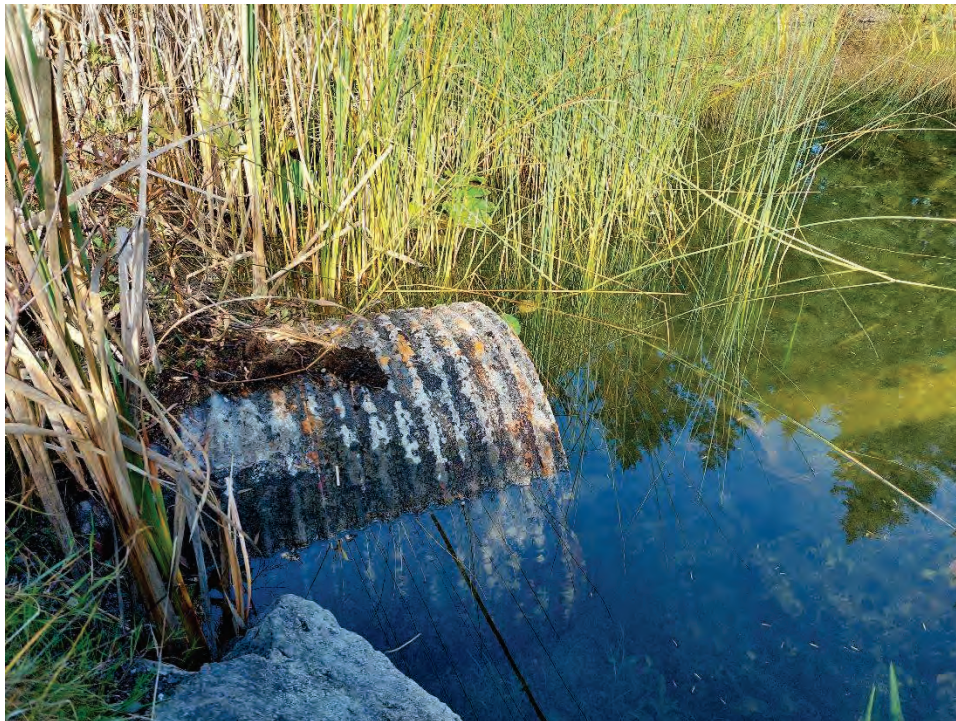
- The visible portion of the culvert outlet appeared to be corroded with damaged coating. The overall culvert condition was not assessed due to the limited inspection.
- The downstream water level appeared to be steady and high, indicating that the culvert does not operate under free flow condition but with backwater from the downstream.

Culvert Outlet: Outlet about 75% submerged and visibly corroded on the outside

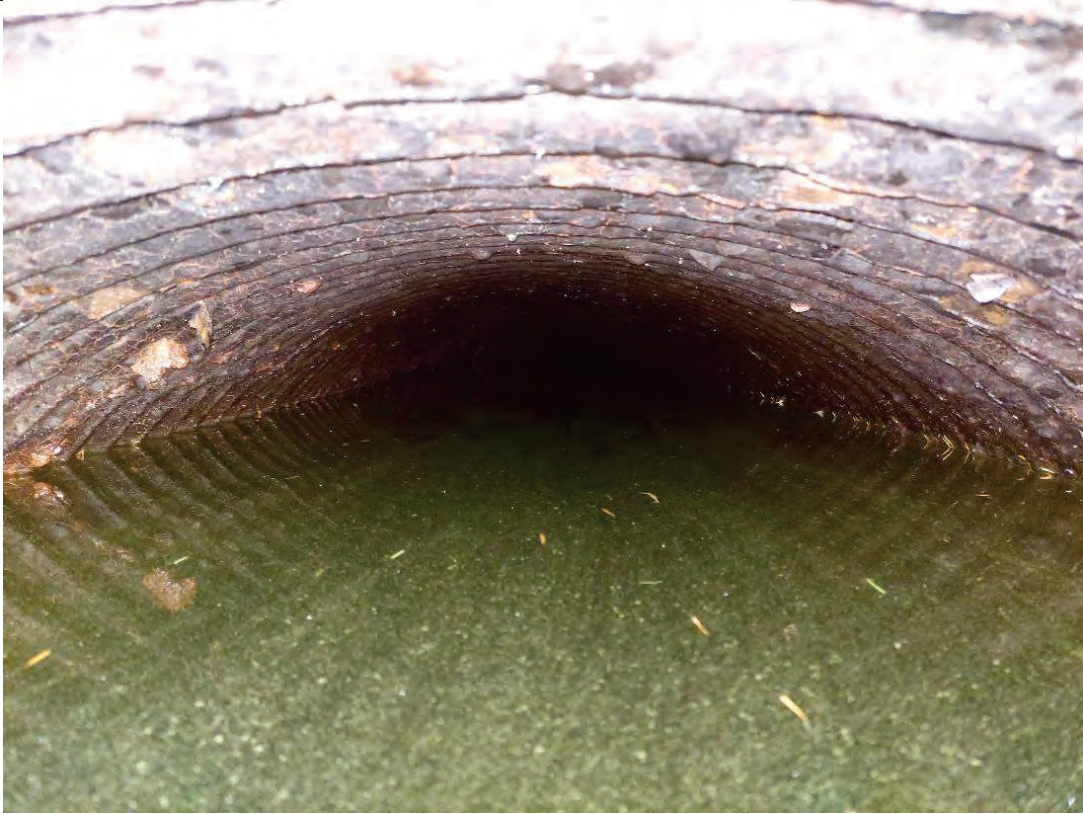
Pipe Interior facing US: Pipe lining visibly damaged with corrosion visible

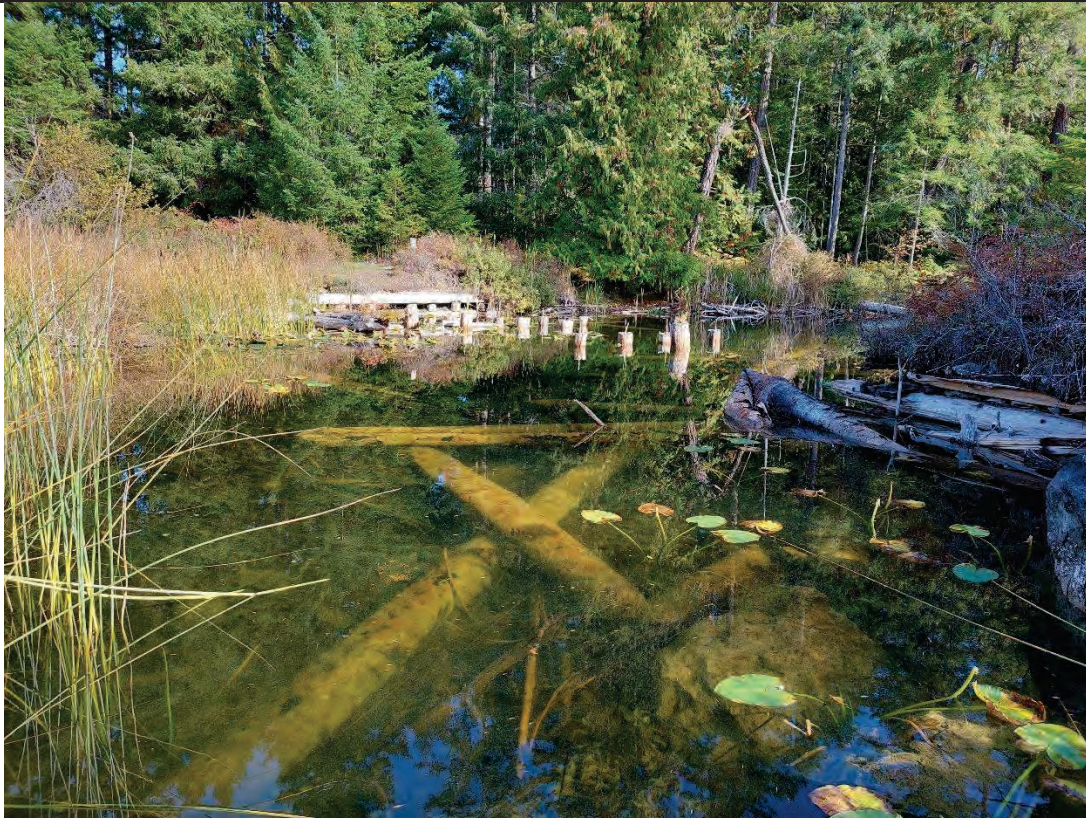
Downstream Channel facing DS: Woody debris and old CSP pipe visible, sensitive habitat for painted turtle

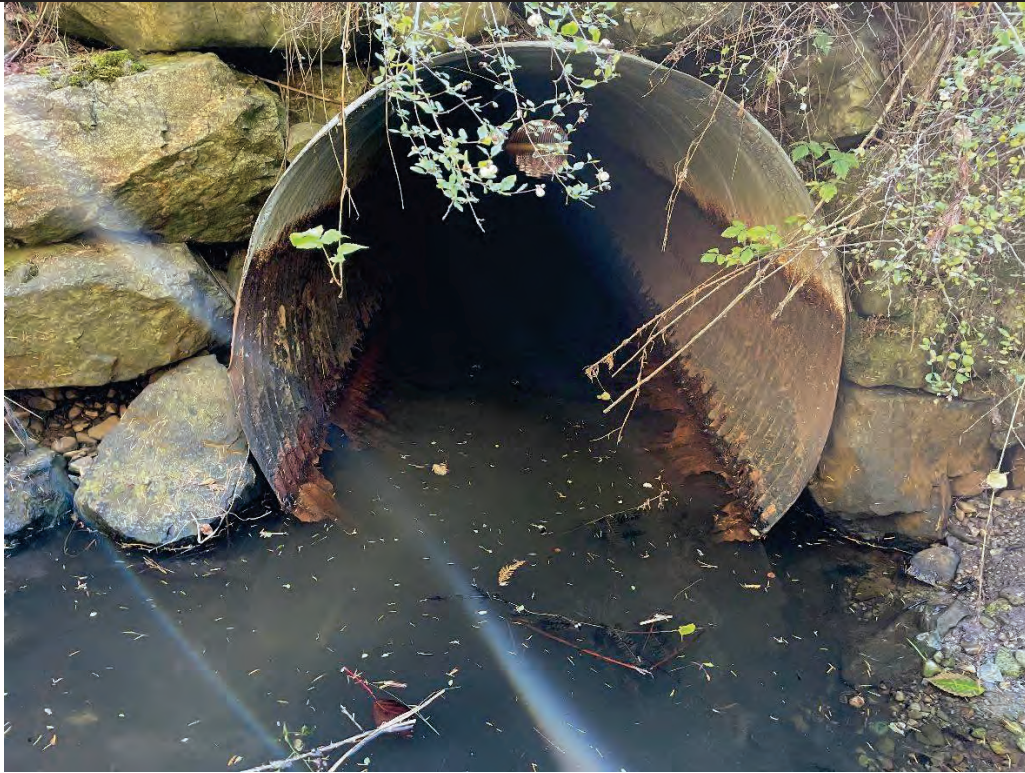
- The culvert invert was visibly corroded with localized significant material loss.
- The culvert appeared to be overall in poor condition and is recommended to be replaced.
- The culvert outlet is next to the confluence of Trout Creek coming from the east and close to the estuary of Cranby Creek.

Culvert Inlet: Heavily corrosion at pipe invert with large section of missing material

<b>MEDIUM-TERM RECOMMENDATIONS (within next 5 years)</b>			
4	<b>Culvert Replacement - Cranby Creek @ Gillies Bay Road</b> (Priority Area 2)	2256032	<ul style="list-style-type: none"> <li>Existing 1,500/1,200 mm CSP culvert is in poor condition and greatly undersized for its large catchment and flows.</li> <li>The replacement culvert was conceptually sized to be a 2,700 x 2,400 mm box culvert, embedded by 480 mm into fish gravel to improve fish-passage. The replacement includes headwalls and wingwalls. <ul style="list-style-type: none"> <li>An alternative culvert was conceptually sized to be a 3,400 x 1,800 mm open-arch culvert.</li> <li>The conceptual size considered a High-Water Level at the downstream of 1.65 m CGVD13, but future sea level rise should be considered during future design stages as well.</li> </ul> </li> </ul>
5	<b>Culvert Replacement - Priest Lake @ Gillies Bay Road</b> (Priority Area 3)	3442936	<ul style="list-style-type: none"> <li>Existing 1,200 mm CSP culvert is greatly undersized without a relief structure and has a history of blockages.</li> <li>The replacement culvert was conceptually sized to be twin 2,100 x 1,800 mm box culverts with wingwalls and headwalls reducing the likelihood of a blockage. <ul style="list-style-type: none"> <li>Priest Lake is an active water reservoir of the Van Anda Improvement District, the downstream pond is a sensitive habitat.</li> <li>A large diameter gas pipeline is located between Priest Lake Road and Gillies Bay Road and would need to be protected or relocated.</li> </ul> </li> </ul>

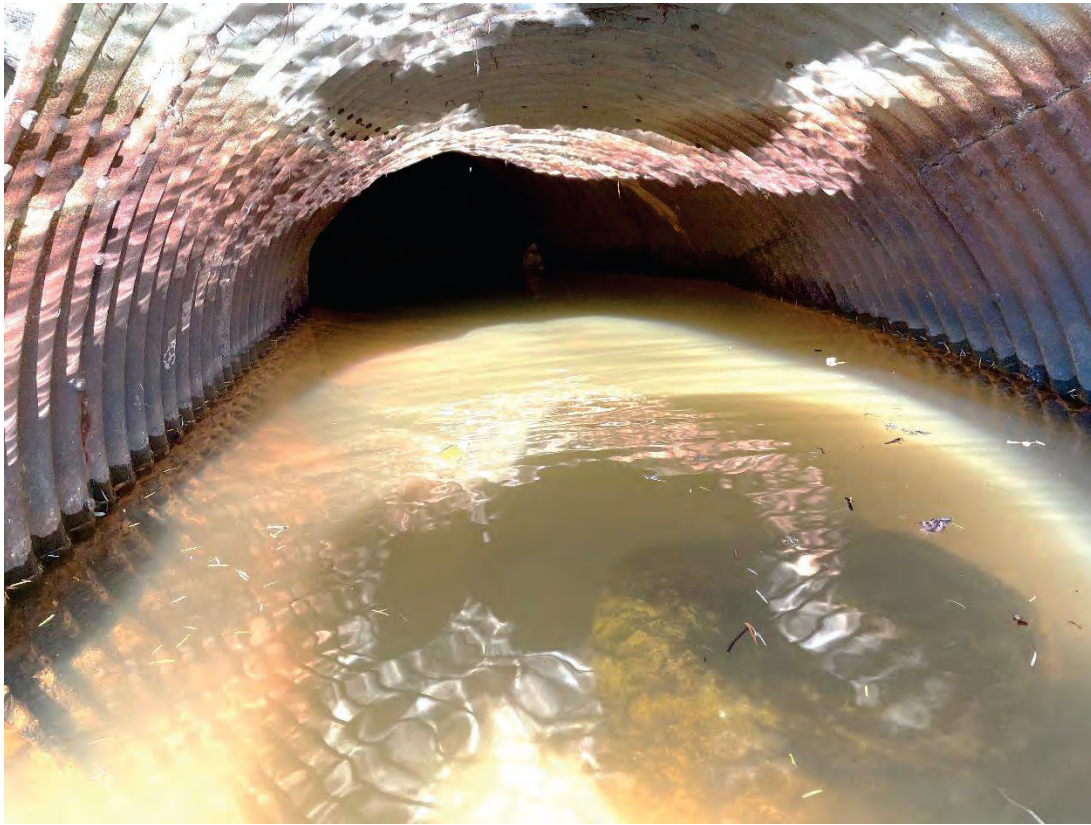
Culvert Interior facing US: Visible pipe joint separation with visible rock on the right side

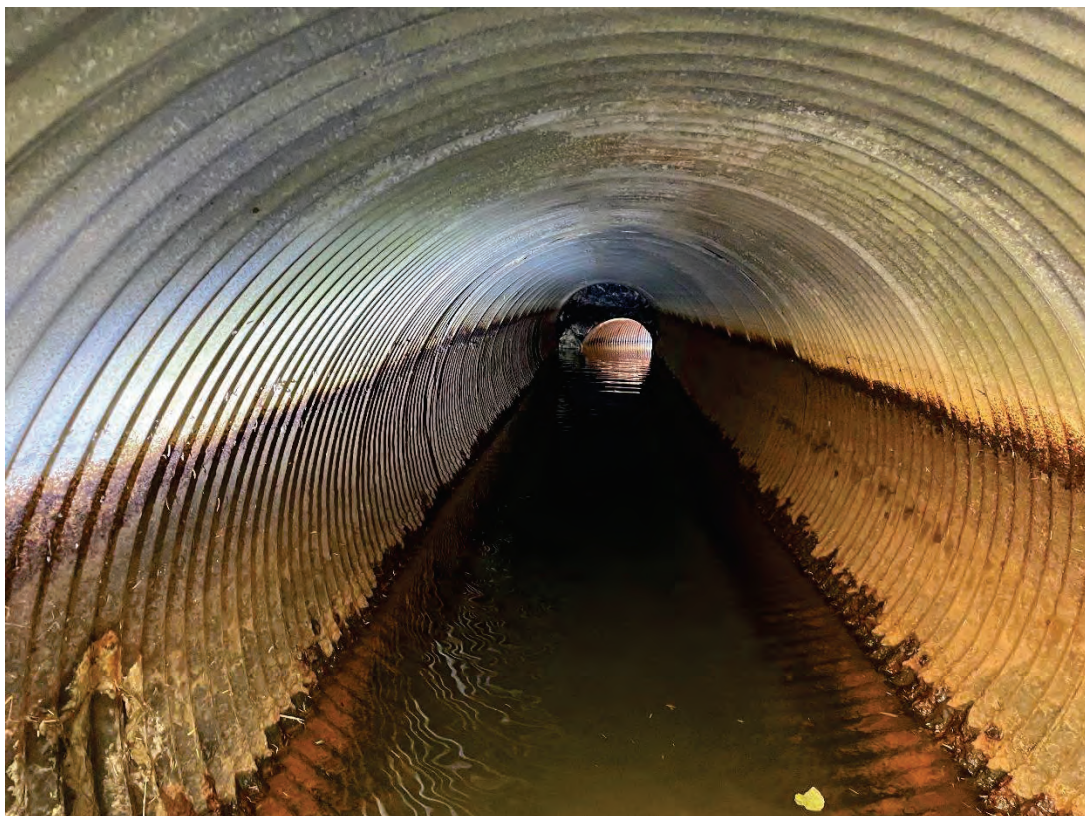
Pipe Interior facing DS: Pipe joint separation visible with skewed outlet pipe and visible rock

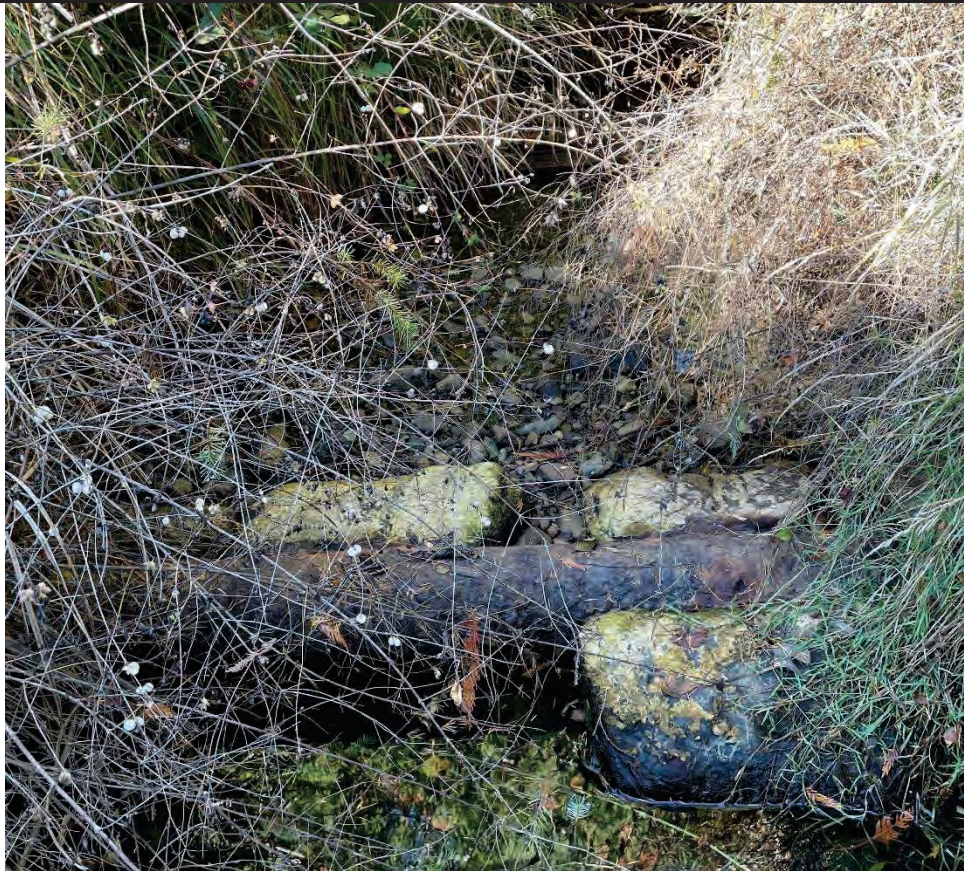
Upstream Channel facing US: DI utility service line visible in the upstream channel 3m from inlet

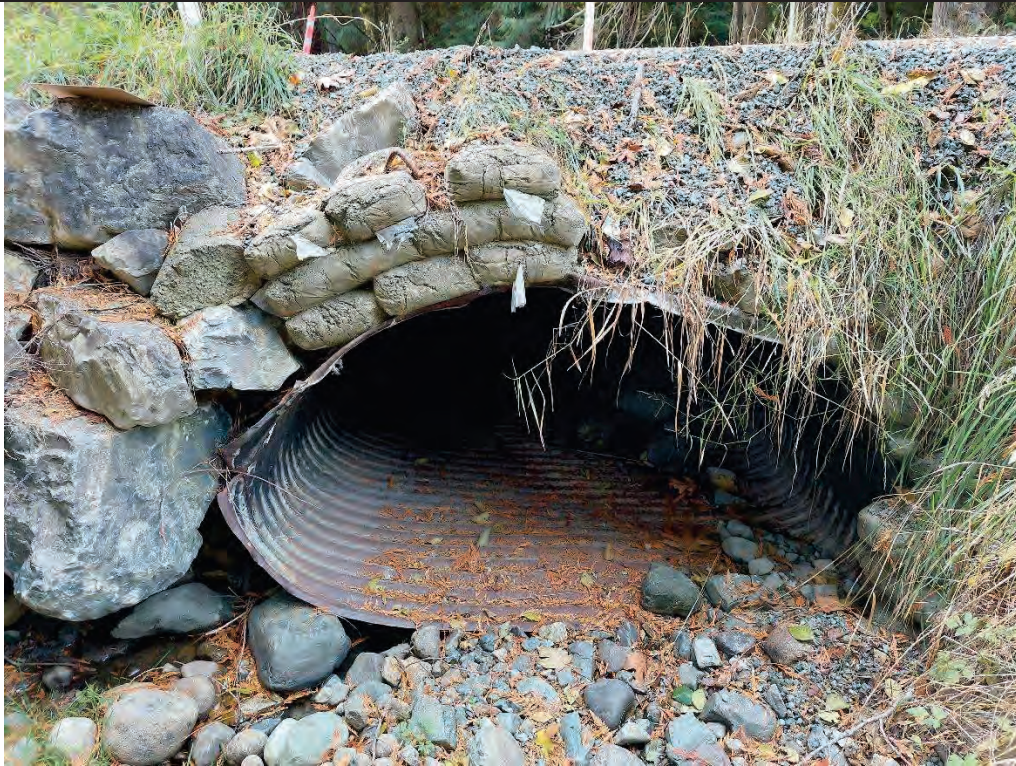
- The outlet road embankment appeared steep and unstable with the road gravel eroding into the channel.
  - The headwall concrete bags had mostly failed, showing cavities around the inlet.

Culvert Inlet: Failed concrete bag headwall, culvert pipe visibly corroded, flow below gravel

6	<b>Culvert Replacement - Staaf Creek @ Bell Road</b> (Priority Area 6)	2254782	<ul style="list-style-type: none"> <li>Existing 1,800 x 1,200 mm CSP arch-pipe culvert is in poor condition and undersized with signs of piping at the crossing.</li> <li>The replacement culvert was conceptually sized to be a 2,800 x 1,500 mm box culvert, embedded by about 300 mm in fish gravel to improve fish passage. The replacement includes headwalls and wingwalls. <ul style="list-style-type: none"> <li>Bell Road might be potentially regraded and raised for the culvert replacement.</li> </ul> </li> </ul>

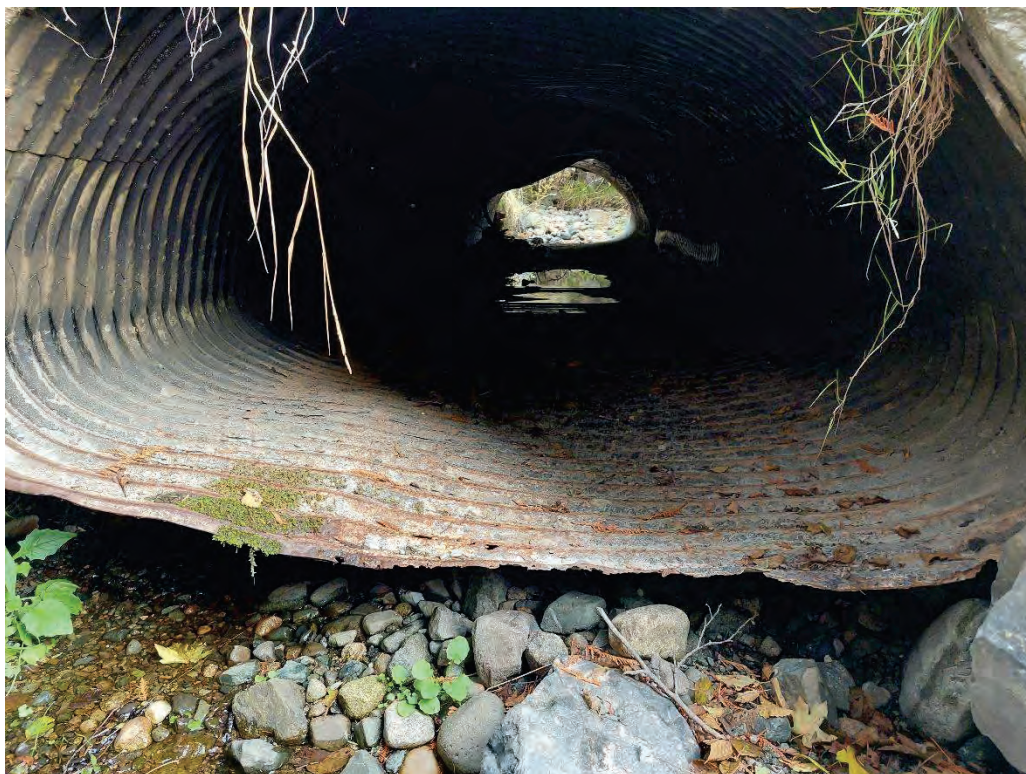
Culvert Outlet: Pipe invert heavily corroded, flow visible coming from under the culvert

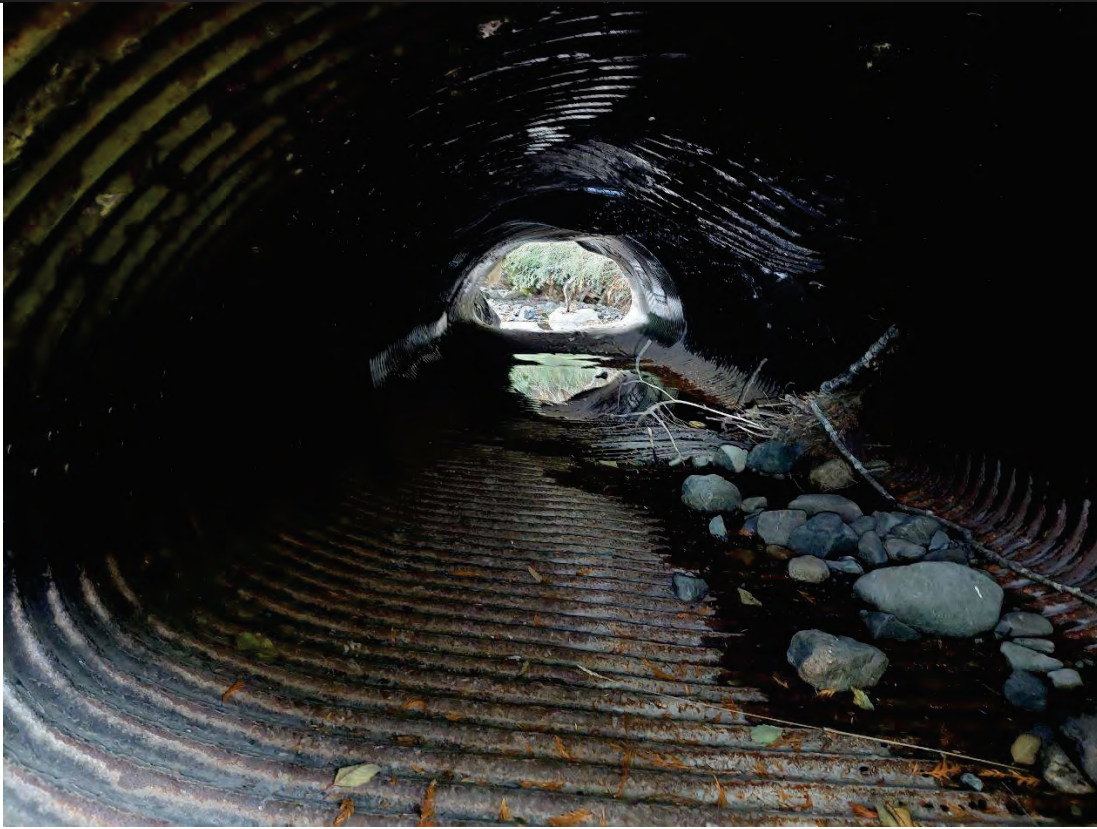
- A single 1,800 x 1,000 mm CSP arch-pipe culvert (2254782) was found at the crossing of Staaf Creek and Bell Road.
  - The culvert showed major buckling and significant corrosion of the pipe invert.

Culvert Interior facing DS: Buckling visible at 2 o'clock, flowing water visible in the middle of the culvert

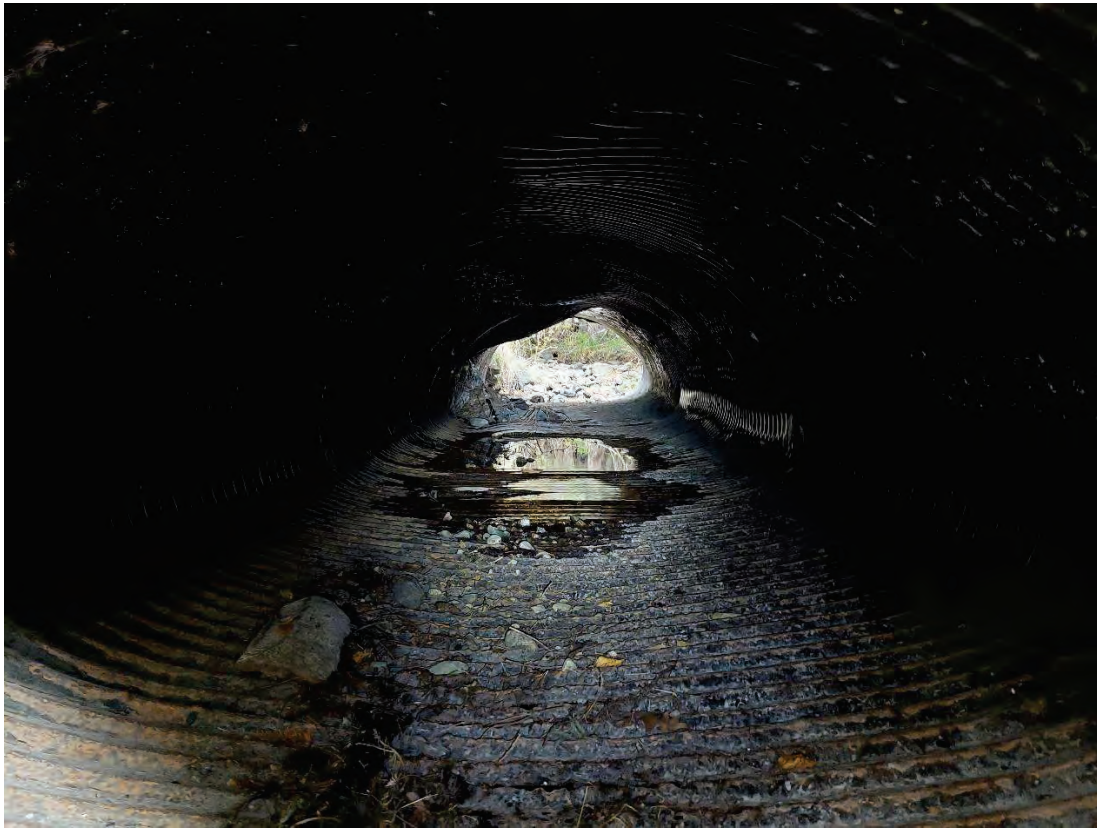
Culvert Inlet facing US: Buckling visible at multiple locations, flow disappearing at pipe invert

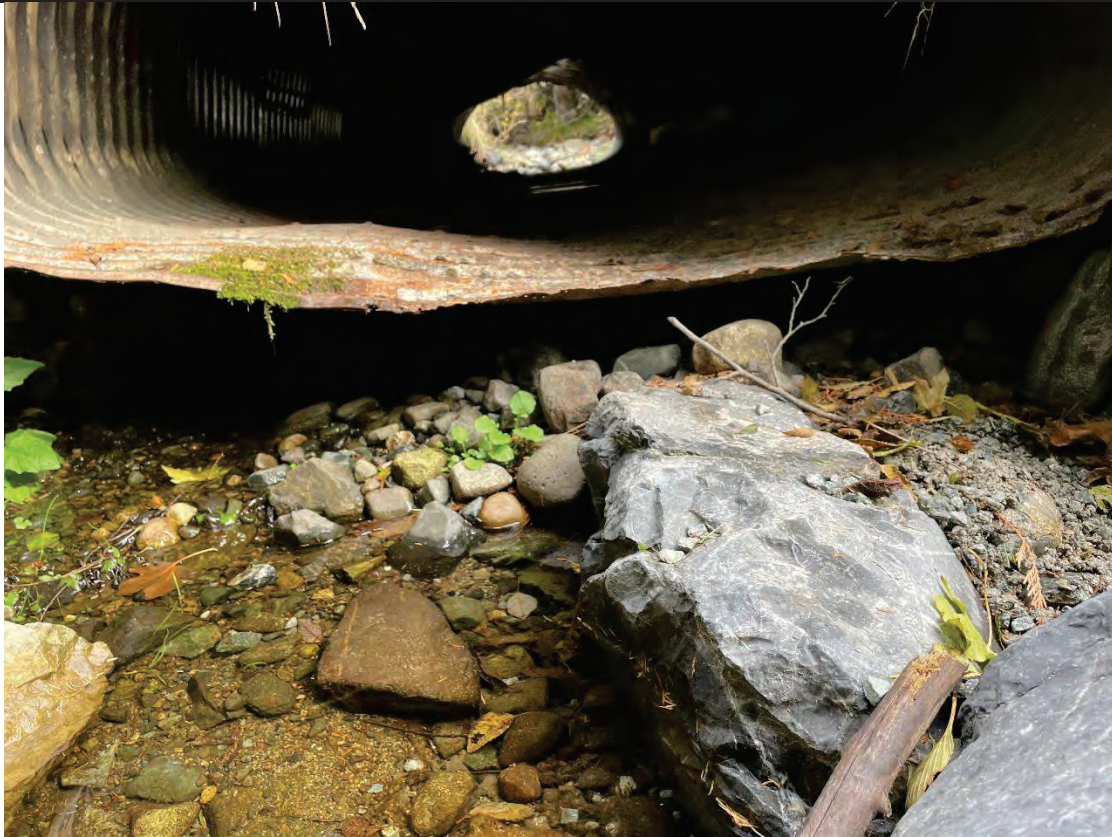
Culvert Outlet: Visible undermining of culvert pipe with visible stream flowing under pipe

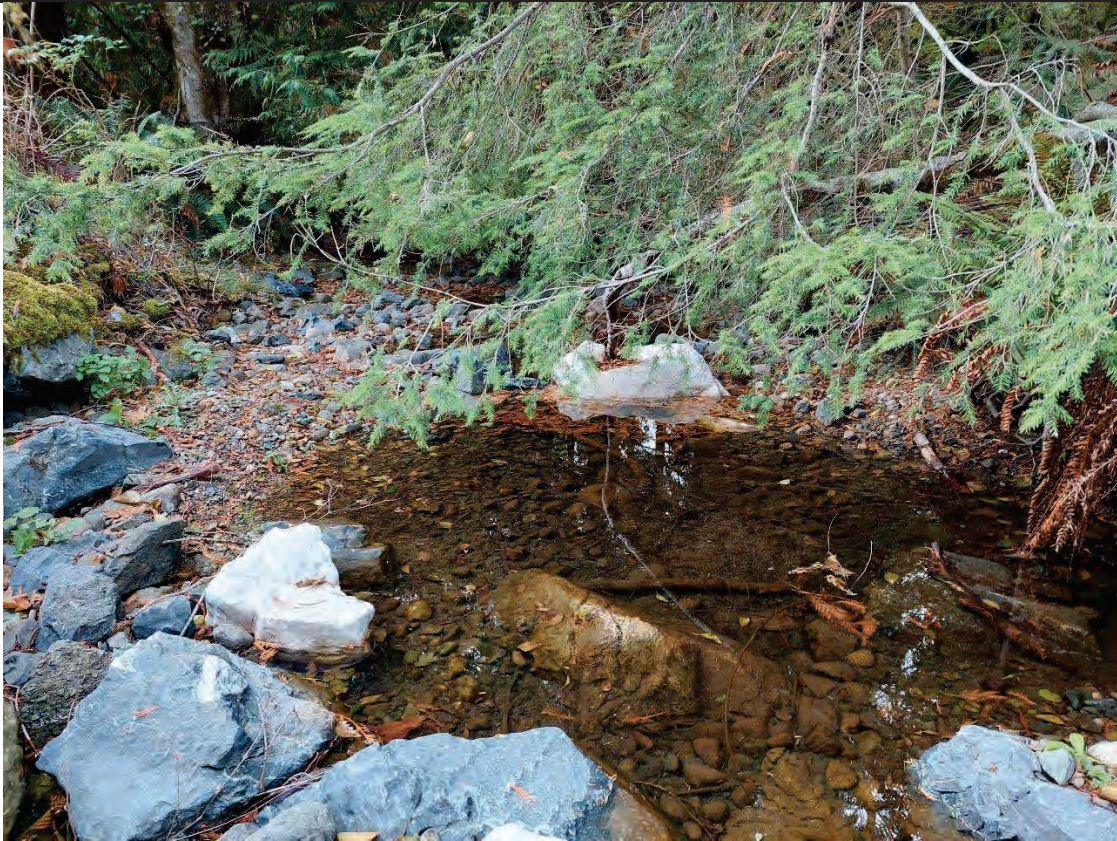
Downstream Channel facing DS: Downstream pool with erosion of banks on both sides

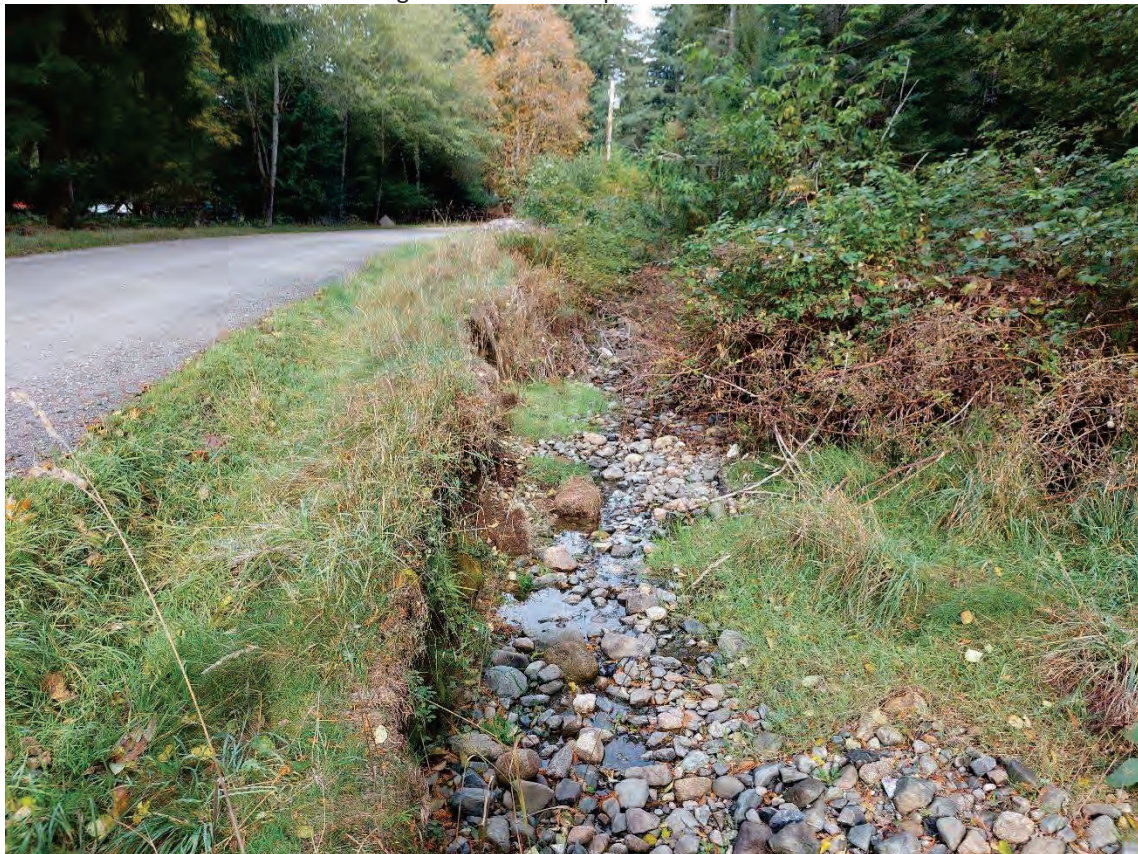
- The culvert appeared to be overall in poor condition.
- Major erosion and active undermining were visible at the south bank of Staaf Creek next to Bell Road along two sections, estimated together at around 25 m. Signs of recently placed fill, rocks and riprap were visible.

Upstream Channel at Bell Rd: Undermining of roadside ditch along 10m stretch

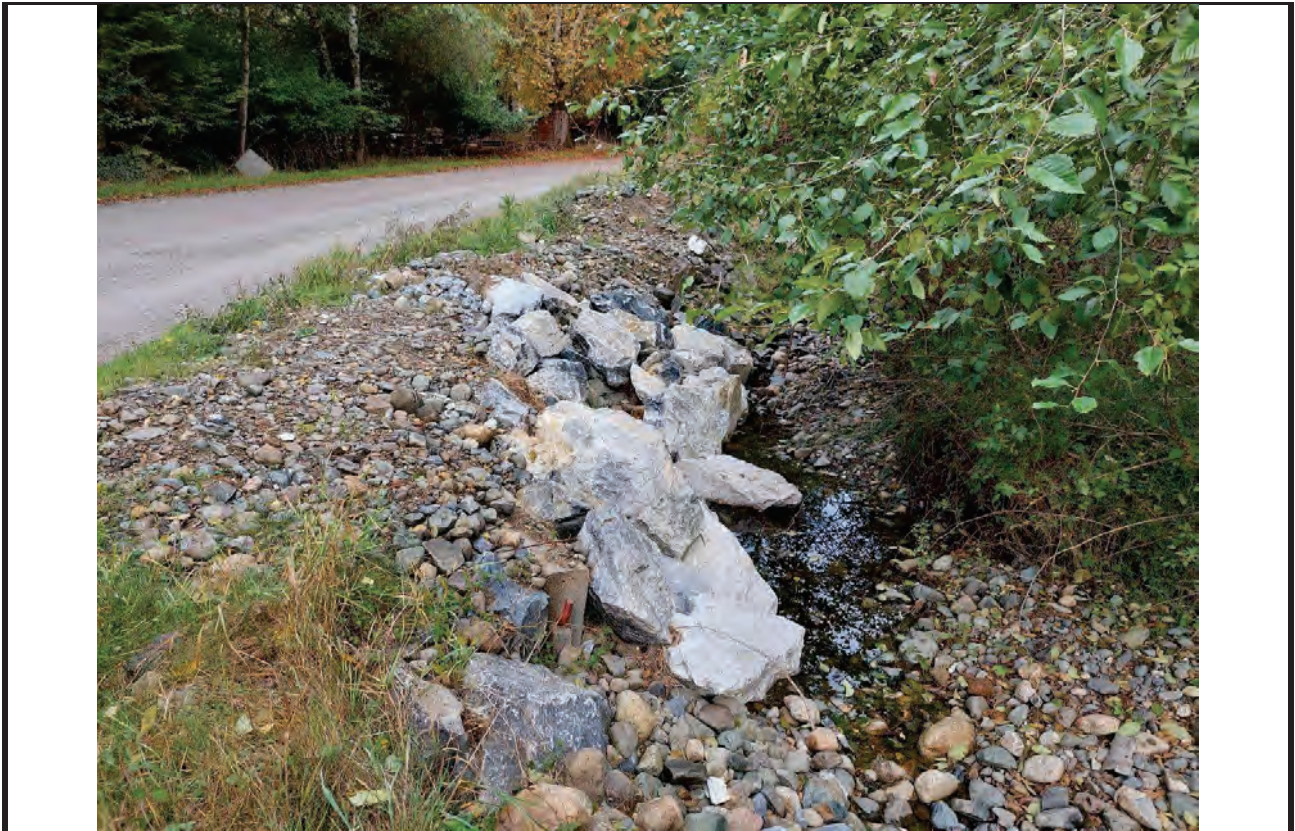
Upstream Channel at Bell Rd: Undermining of embankment along 14m stretch, dumped riprap visible
