Ministry of  
Transportation  
and Infrastructure

# Texada Island Drainage Study

Final Report

January 2024

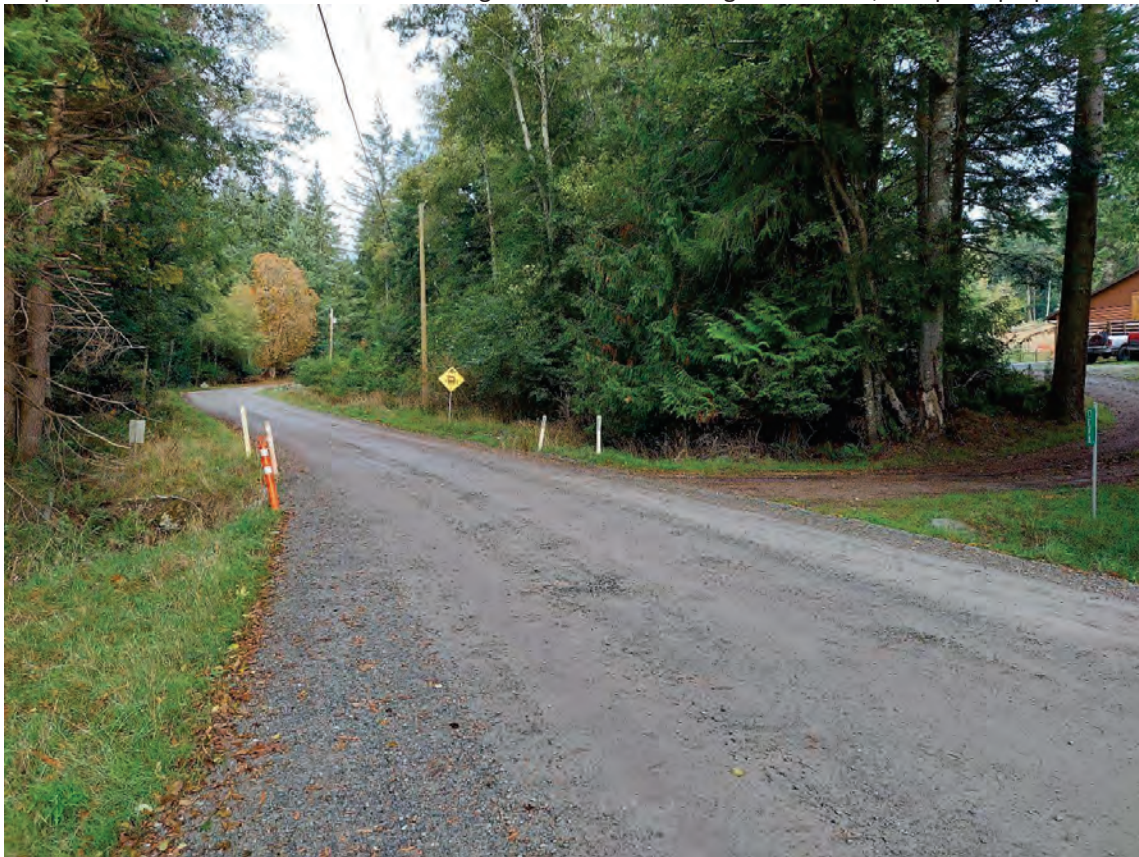
Bell Road above Staaf Creek: Gravel Road with eroding road embankment on the left side visible

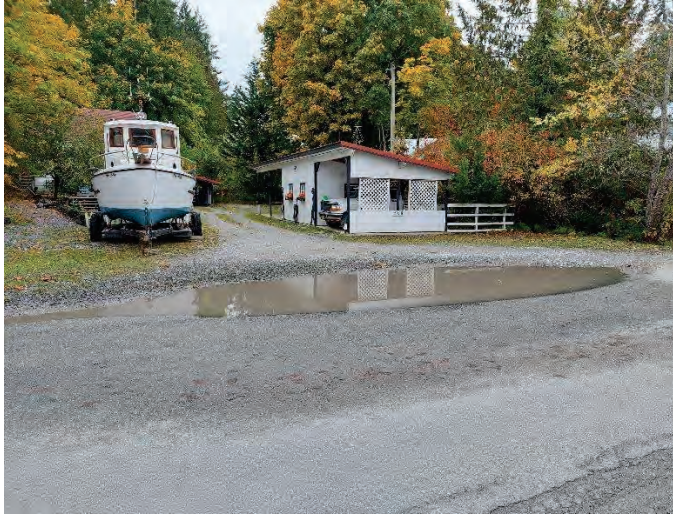
- A big puddle on the southside of 2058 Marble Road extending half into the lane was visible, potentially impacting traffic. An existing 450 mm CSP culvert (CHRIS: 2257259) immediately west conveying a small creek under Marble Road was inspected and found to be in fair condition.
- A circular 600 mm wood stave culvert (CHRIS: 3442931) was inspected crossing Marble Road west of Colburn Street and found in fair condition with significant flow at the time of inspection.
- A 600 mm CSP culvert that has been extended with a 450 mm HDPE pipe next to the Texada Island Boat Yard has been inspected and found to be in fair condition.

AREA 2 MARBLE RD: PUDDLE AT 2058 MARBLE RD SOUTHERN LANE

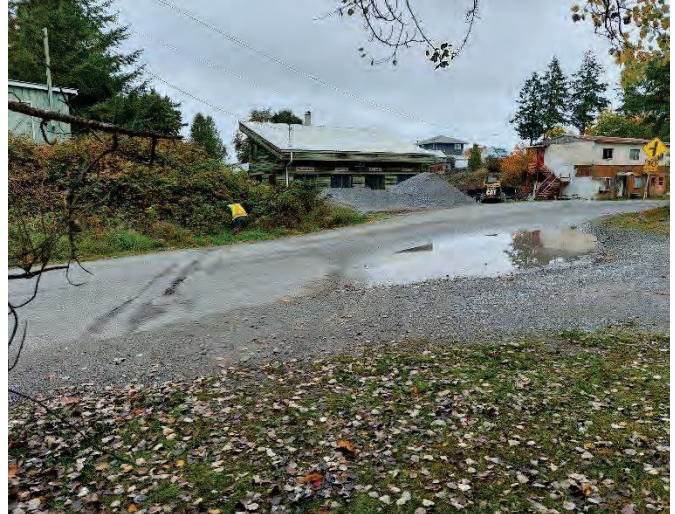
AREA 2 MARBLE RD: CROSS CULVERT UNDER PAVEMENT CRACK LINES

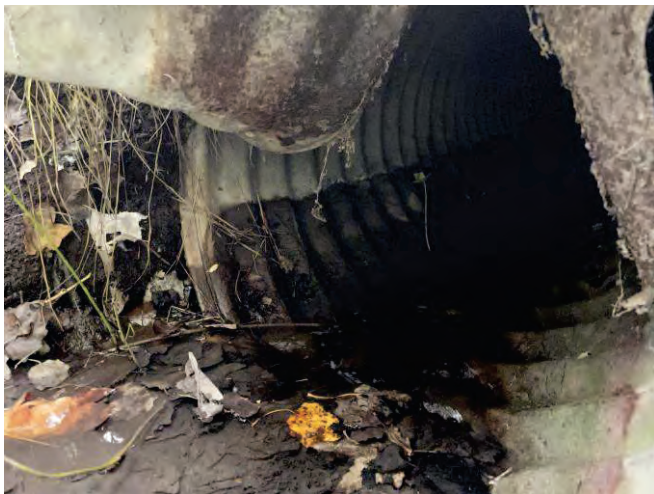
AREA 2 MARBLE RD: 450MM CSP CROSS CULVERT (2257259) LOOKING DOWNSTREAM

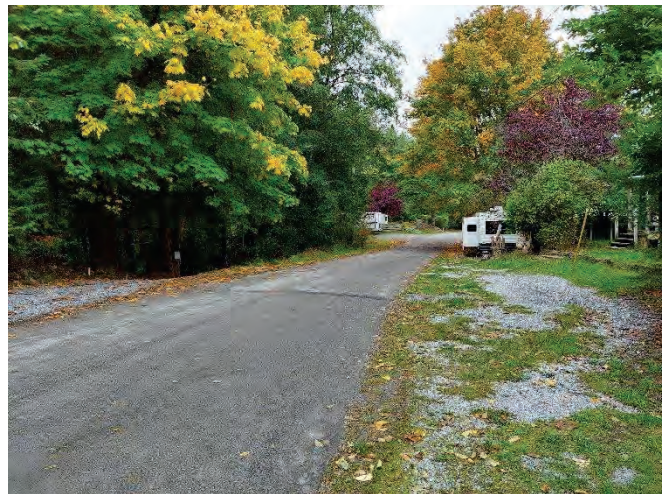
AREA 2 MARBLE RD: NO DRAINAGE ALONG PARTS OF MARBLE RD

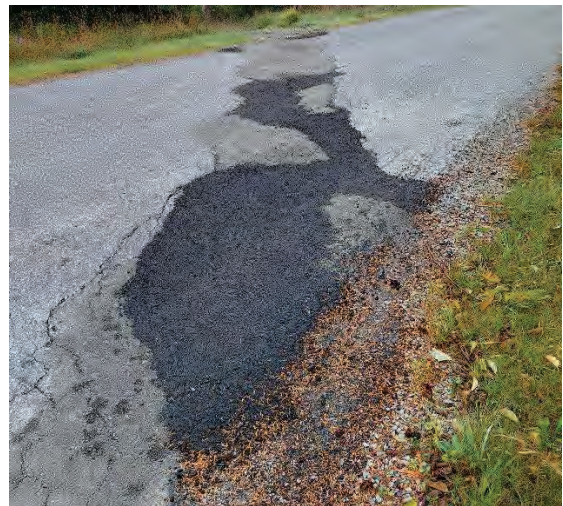
- The culvert appeared to have insufficient cover of less than 15 cm and a very poorly constructed pavement restoration with potholes, cracks, and settlement around the pipe.

AREA 4 AIRPORT RD: NEW CULVERT, POOR PAVEMENT INSTALLATION WITH TENSION CRACKS AND SETTLEMENT

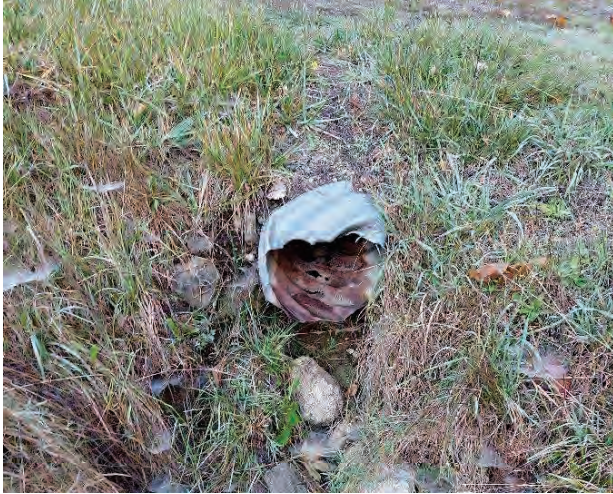
AREA 4 AIRPORT RD: 300MM CSP CULVERT (2258675) OUTLET, CORRODED INVERT

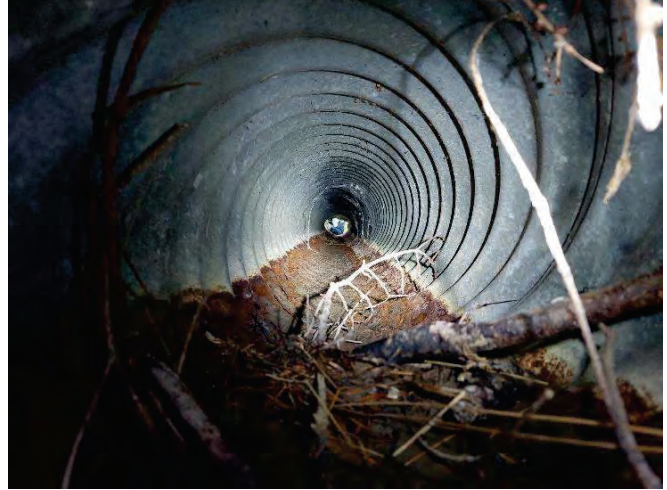
- The culvert pipe alignment is bent with minor pipe joint separation visible. The overall culvert condition appeared to be fair.
- A 300 mm CSP culvert (CHRIS: 2258675) was inspected at the water tank driveway with a heavily corroded pipe invert and in poor condition.

AREA 4 AIRPORT RD: 300MM CSP CULVERT (2258675), HEAVILY CORRODED INVERT

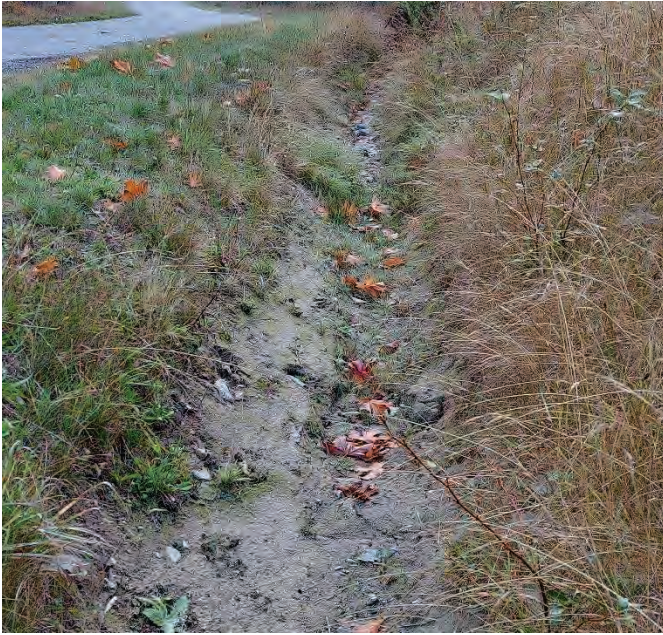
AREA 4 AIRPORT RD: EROSION OF ROADSIDE DITCH

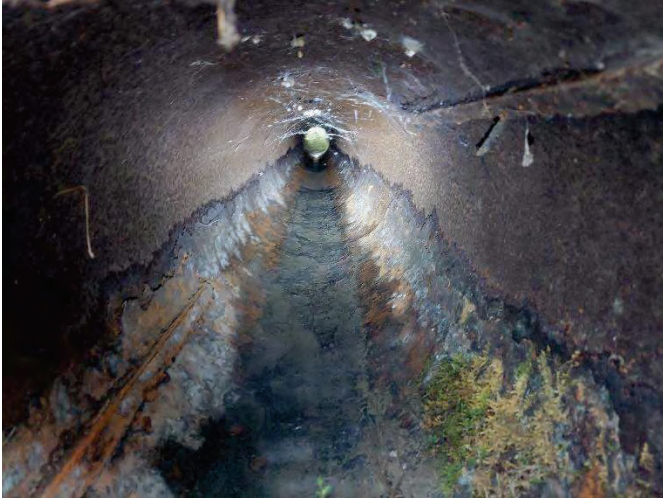
- A 450mm DI culvert was inspected south of the water tank with only surficial corrosion and in overall fair condition (49.682369°N, 124.490133°W).
- The western roadside ditch along Airport Road showed multiple locations with visible erosion and scour, likely from the high flows in the ditch due to the high slope between the water tank and Pine Street.

AREA 4 AIRPORT RD: 450MM DI CULVERT INTERIOR, SURFICAL CORROSION

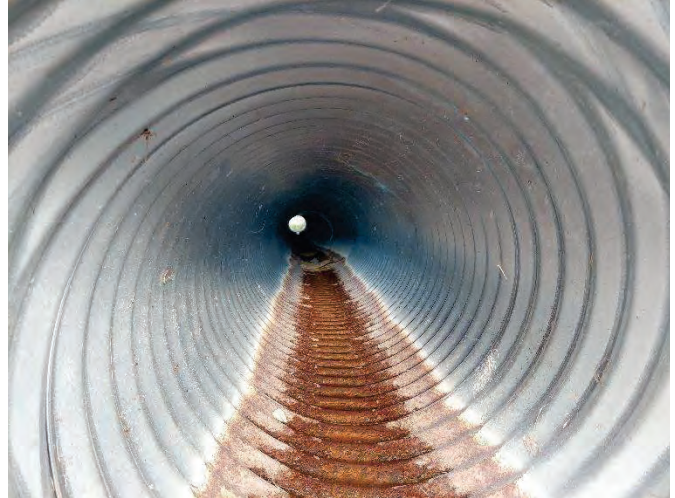
- A 600 mm CSP culvert (CHRIS 2256637) crossing under Pine Street was inspected with visible corrosion of the pipe invert and a damaged inlet but overall, in a fair condition.

AREA 4 AIRPORT RD: 600MM CSP CULVERT (2256637) UNDER PINE ST INTERIOR, PIPE INVERT CORROSION

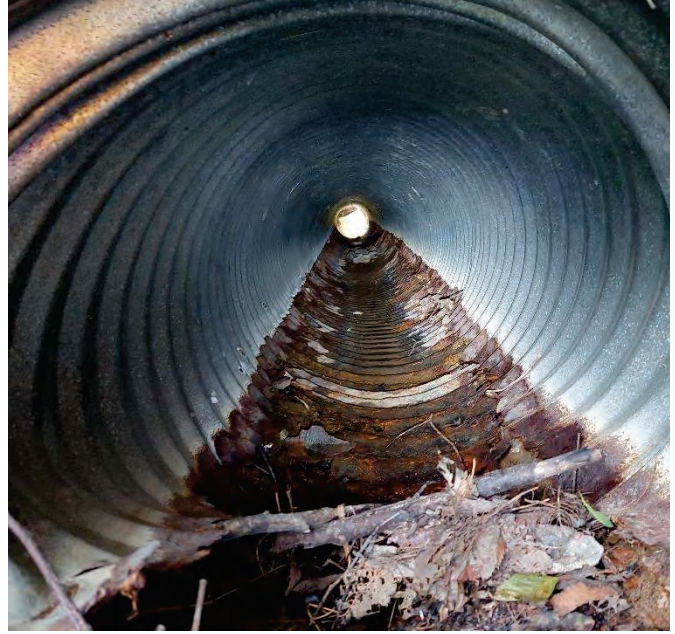
- The western pipe appeared to be recently installed and in good condition. The pipe appeared not be fully aligned with the ditch.
  - The eastern pipe appeared to be older with significant corrosion and loss of material and in poor condition.

AREA 4 GILLIES BAY RD: OLD EASTERN 600MM CSP CULVERT, MAJOR CORROSION OF PIPE INVERT

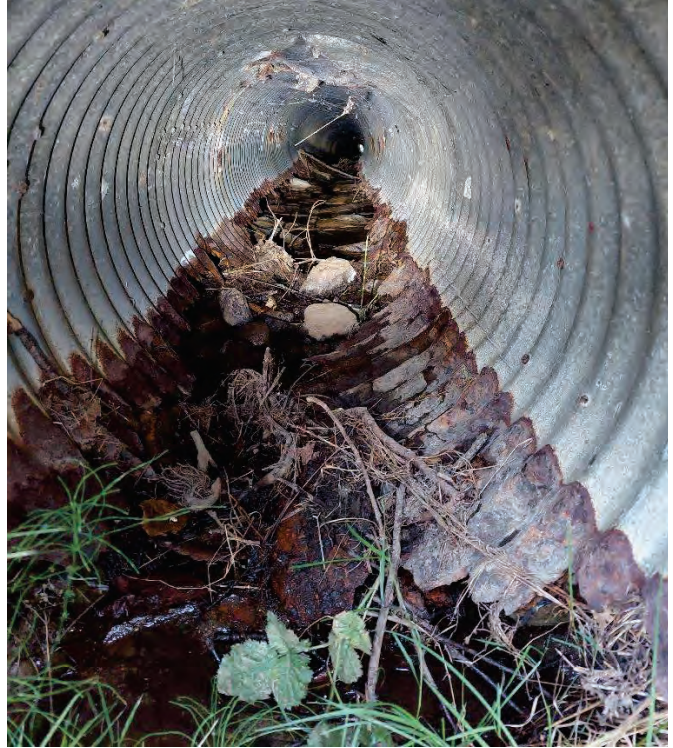
- The culvert had significant corrosion of the pipe invert with complete loss of material. It appeared to be in poor condition.
  - The location of the culvert just downstream of the twin 600 mm CSP appears significant for its compared small conveyance capacity and may indicate that the culvert is undersized.

AREA 4 SANDERSON RD: CULVERT (2258625) PIPE INVERT CORRODED AWAY LOOKING DOWNSTREAM

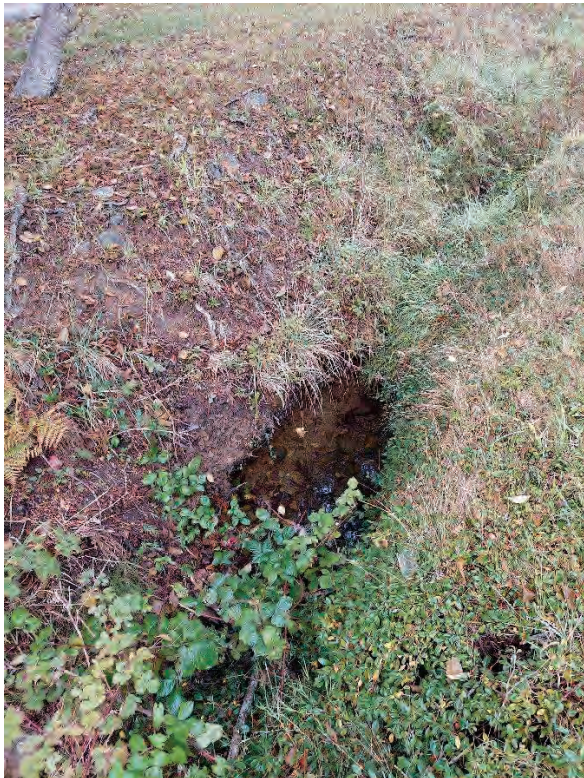
AREA 4 GILLIES BAY RD: BANK EROSION OF ROADSIDE DITCH

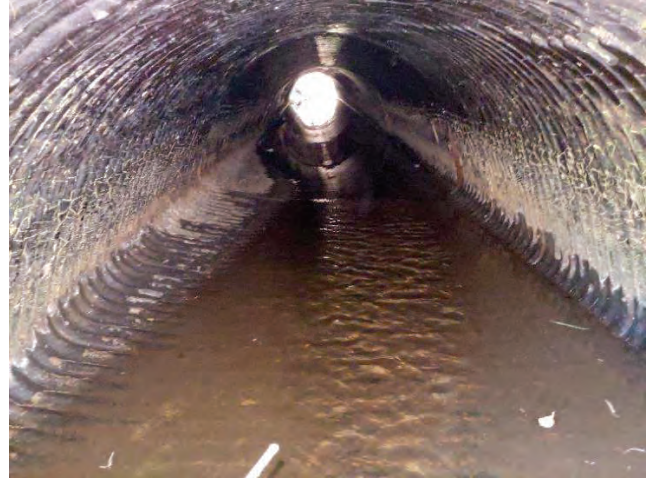
AREA 5 GILLIES BAY: ARCH PIPE (2256032) WITH LOCAL CORROSION

7	<b>Culvert Replacement - Trout Creek @ Gillies Bay Road</b> (Priority Area 5)	2256032	<ul style="list-style-type: none"> <li>Existing 1,800 x 1,100 mm CSP arch-pipe culvert is in fair condition but greatly undersized and known for seasonal floodings around Gillies Bay Road.</li> <li>The replacement culvert was conceptually sized to be a 4,300 x 1,500 mm open bottom arch culvert with headwalls and wingwalls. Note that the culvert for the conceptual size appeared to be outlet controlled and a headloss of 0.3 m has not been achieved. The culvert should be analyzed in detail at a later stage.</li> </ul>
8	<b>Culvert Replacement &amp; Valley Curb Installation – Marble Road</b>	2257259	<ul style="list-style-type: none"> <li>Existing 450 mm CSP culvert is in fair condition but greatly undersized.</li> <li>The replacement culvert recommended is a 1,200 x 600 mm box culvert.</li> <li>A new valley curb is recommended to be installed along the southside of Marble Road towards the small creek in the west on an approx. length of 18 metres.</li> </ul>

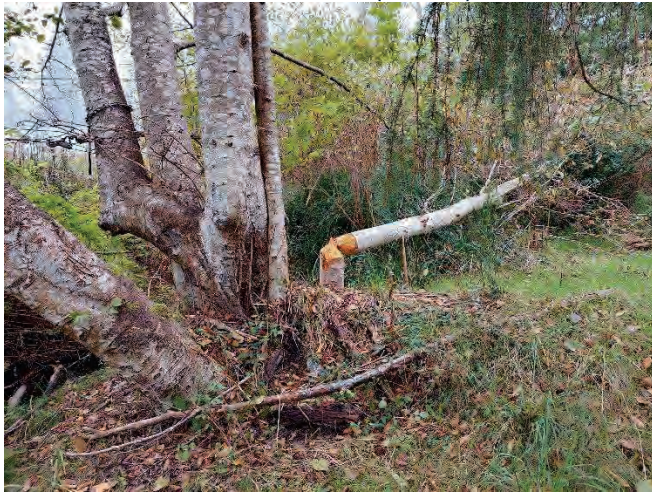
AREA 5 GILLIES BAY: SIGNS OF BEAVERS UPSTREAM OF CULVERT

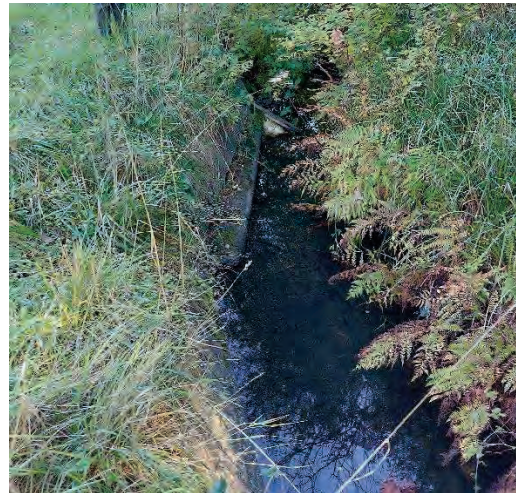
AREA 5 GILLIES BAY: SIGNS OF FAILED CONCRETE EMBANKMENT

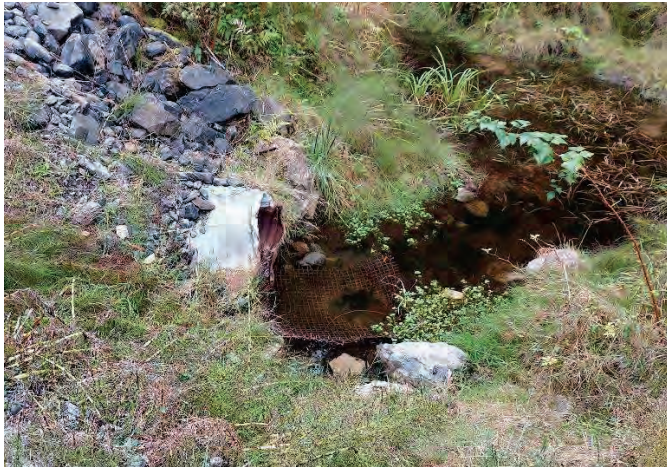
CULVERT	NOTES
Culvert 1 – Blubber Bay Road (CHRIS ID: 2254949)	<ul style="list-style-type: none"> <li>• 900mm CSP culvert, appears overall in <u>fair condition</u>.</li> <li>• Inlet damaged, pipe invert corroded and most of pipe coating is lost.</li> <li>• Inlet grate damaged and not attached to the inlet.</li> <li>• Pipe transitions from galvanized heavily corroded CSP at the inlet to coated CSP with minor corrosion.</li> </ul>
Culvert 4 – Gillies Bay Road (CHRIS ID: 2256045)	<ul style="list-style-type: none"> <li>• 1050mm CSP culvert, appears overall in <u>fair condition</u>.</li> <li>• Lower half of the culvert corroded with woody debris in the pipe.</li> <li>• Culvert outlet not inspected as heavily overgrown.</li> </ul>
Culvert 5 – Gillies Bay Road (CHRIS ID: 2256047)	<ul style="list-style-type: none"> <li>• 1200mm CSP culvert, appears overall in <u>fair condition</u>.</li> <li>• Pipe coating mostly intact but starting to fail on both sides.</li> <li>• Minor pipe joint separation and debris within pipe.</li> <li>• Road embankment erosion at the outlet.</li> </ul>

CULVERT 1 (2254949) INLET: DAMAGED INLET AND GRATE

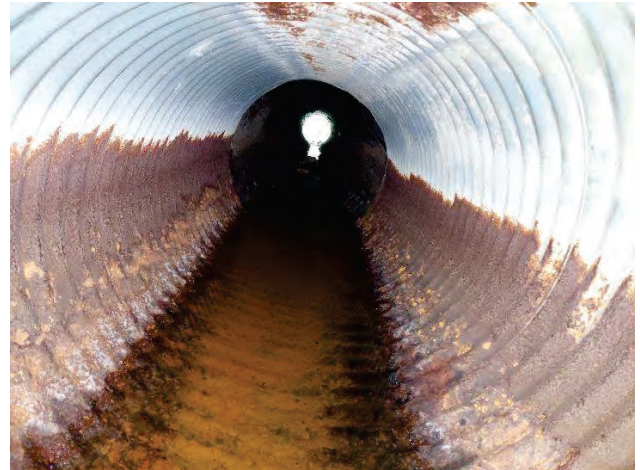
CULVERT 1 (2254949) INTERIOR: MATERIAL CHANGE AND HEAVY CORROSION

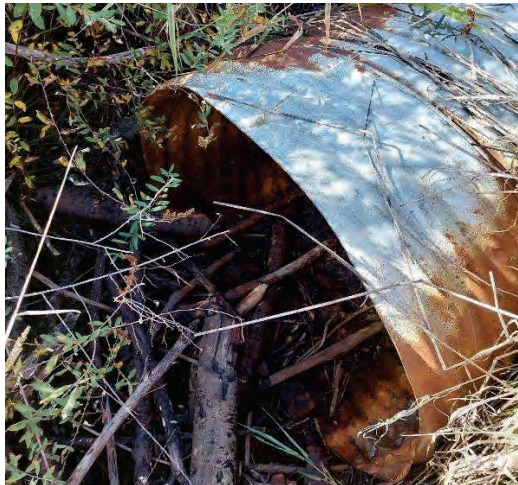
CULVERT 4 (2256045) INLET: MINOR WOODY DEBRIS

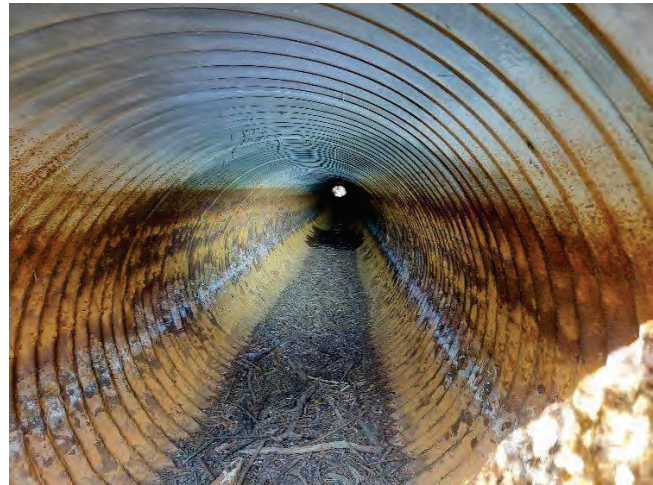
CULVERT 4 (2256045) INTERIOR: MAJOR CORROSION & MINOR DEBRIS

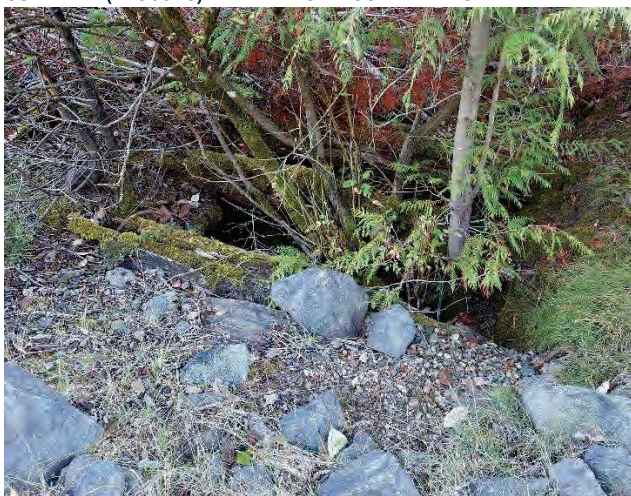
CULVERT 5 (2256047) INLET: VEGETATION PRESENT AT INLET

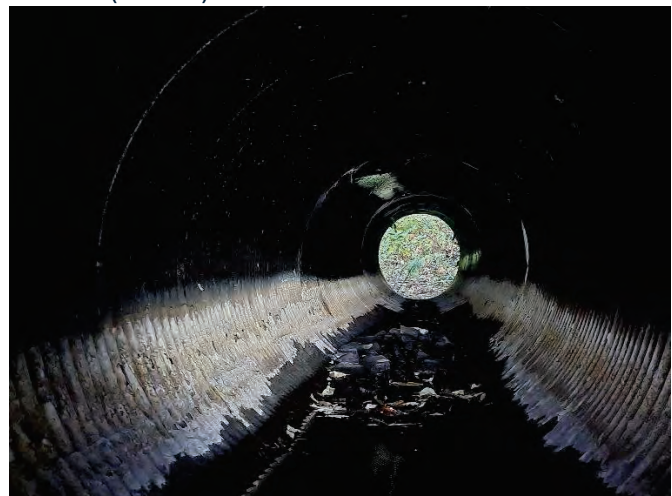
CULVERT 5 (2256047) INTERIOR: DAMAGED COATING AND MINOR ROCK

DEBRIS

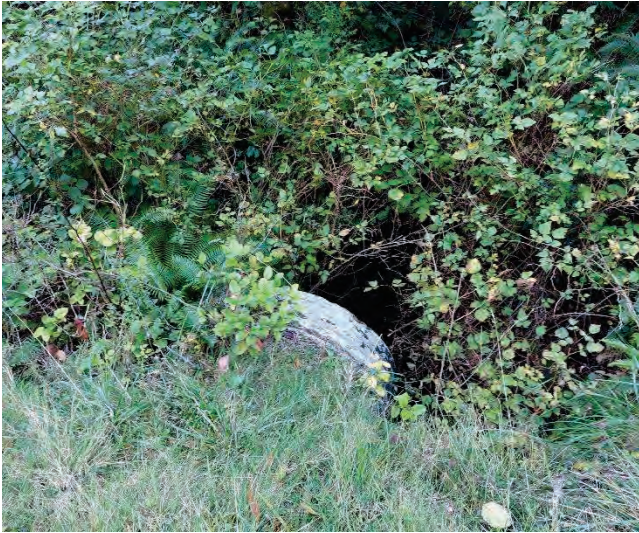
Culvert 6 – Gillies Bay Road (CHRIS ID: 2256019)	<ul style="list-style-type: none"> <li>• 1050mm CSP culvert, appears overall in <u>fair condition</u>.</li> <li>• Pipe joint separation at the middle of the culvert.</li> <li>• Gravel and rock debris present ~ 15%.</li> </ul>
Culvert 7 – Sanderson Road (CHRIS ID: 2258625)	<ul style="list-style-type: none"> <li>• 525mm CSP culvert, appears overall in <u>poor condition</u>.</li> <li>• Pipe invert completely corroded away, and underlying sediment partly washed out.</li> <li>• Pipe likely undersized, as it drains Airport Rd and Gillies Bay Rd.</li> </ul>
Culvert 9 – Shelter Point Road (CHRIS ID: 2256424)	<ul style="list-style-type: none"> <li>• 1200mm CSP, appears overall in <u>fair condition</u>.</li> <li>• Woody debris at inlet. Pipe coating appears to be mostly intact.</li> <li>• Plunge pool present at the outlet with minor scour.</li> </ul>
Culvert 11 – Bell Road (CHRIS ID: 2254788)	<ul style="list-style-type: none"> <li>• 900mm CSP, appears overall in <u>good condition</u>.</li> <li>• Inlet and outlet bend.</li> <li>• Road embankment at outlet unstable, eroding the gravel road.</li> </ul>

CULVERT 6 (2256019) INLET: OVERGROWN INLET

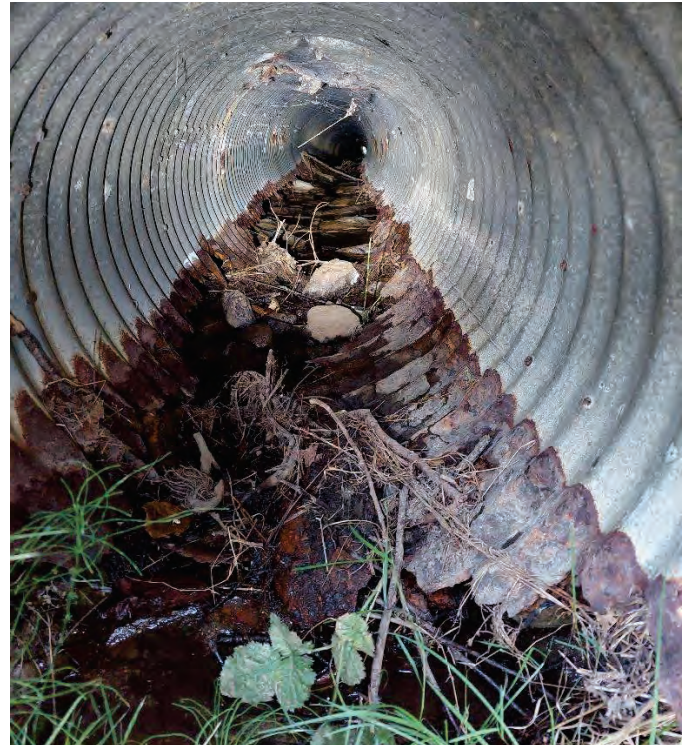
CULVERT 7 (2258625) INTERIOR: PIPE INVERT CORRODED AWAY

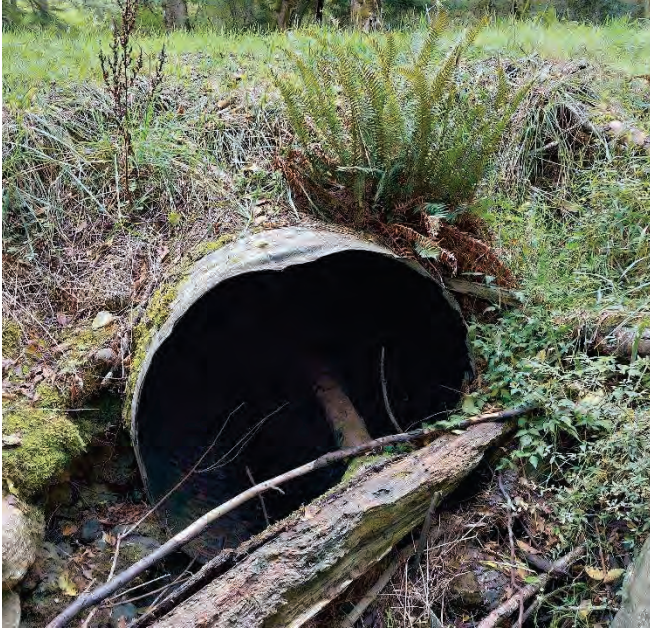
CULVERT 9 (2256424) INLET: WOODY DEBRIS AT INLET

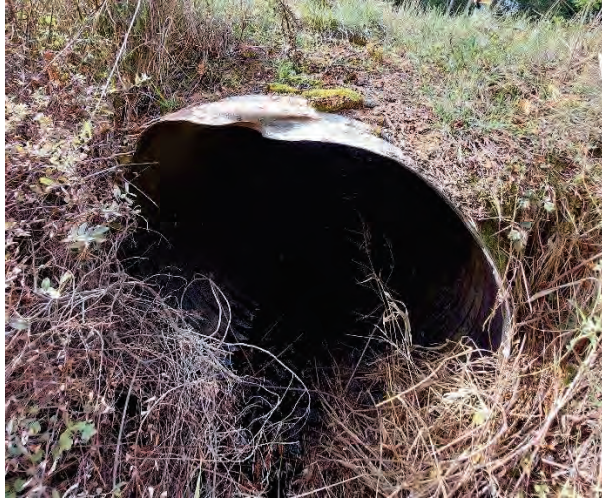
Culvert 12 – Central Road (CHRIS ID: 2255061)	<ul style="list-style-type: none"> <li>• 1200mm CSP, appears overall in <u>poor condition</u>.</li> <li>• Major buckling at 12 o'clock and significant pipe joint separation in the pipe middle.</li> <li>• Pipe coating mostly intact.</li> </ul>
Culvert 13 – Central Road (CHRIS ID: 3442926)	<ul style="list-style-type: none"> <li>• 1050mm CSP, appears overall in <u>good condition</u>.</li> <li>• Active flow present during inspection.</li> <li>• Pipe coating mostly intact with only minor corrosion.</li> </ul>
Culvert 14 – Central Road (CHRIS ID: 3442927)	<ul style="list-style-type: none"> <li>• 1050mm CSP, appears overall in <u>fair condition</u>.</li> <li>• Minor pipe joint separation.</li> <li>• Pipe coating mostly intact</li> </ul>
Culvert 15 – Central Road (CHRIS ID: 2255027)	<ul style="list-style-type: none"> <li>• 2200 x 1350mm CSP arch-pipe, appears overall in <u>fair condition</u>.</li> <li>• Notable corrosion and abrasion of the pipe invert with notable local material loss.</li> <li>• Bank erosion downstream of the culvert.</li> <li>• Gravel potholes present on top of the culvert.</li> </ul>

CULVERT 12 (2255061) INLET: INLET BEND

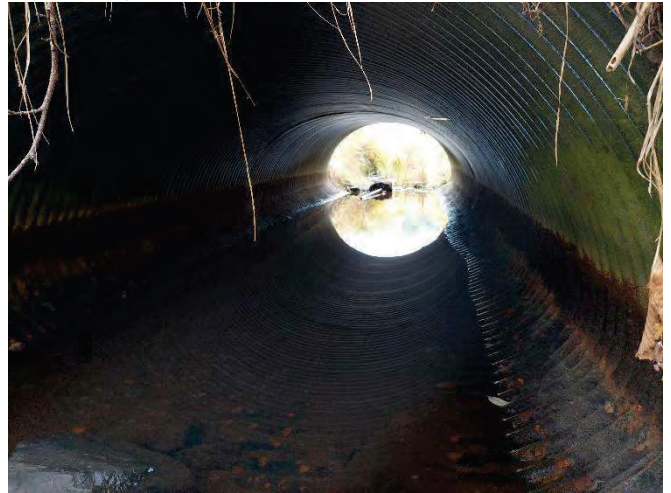
CULVERT 15 (2255027) INTERIOR: SIGNIFICANT CORROSION OF PIPE INVERT
