VAN ANDA IMPROVEMENT DISTRICT

WATER SYSTEM

ASSESSMENT STUDY REPORT

December 2008

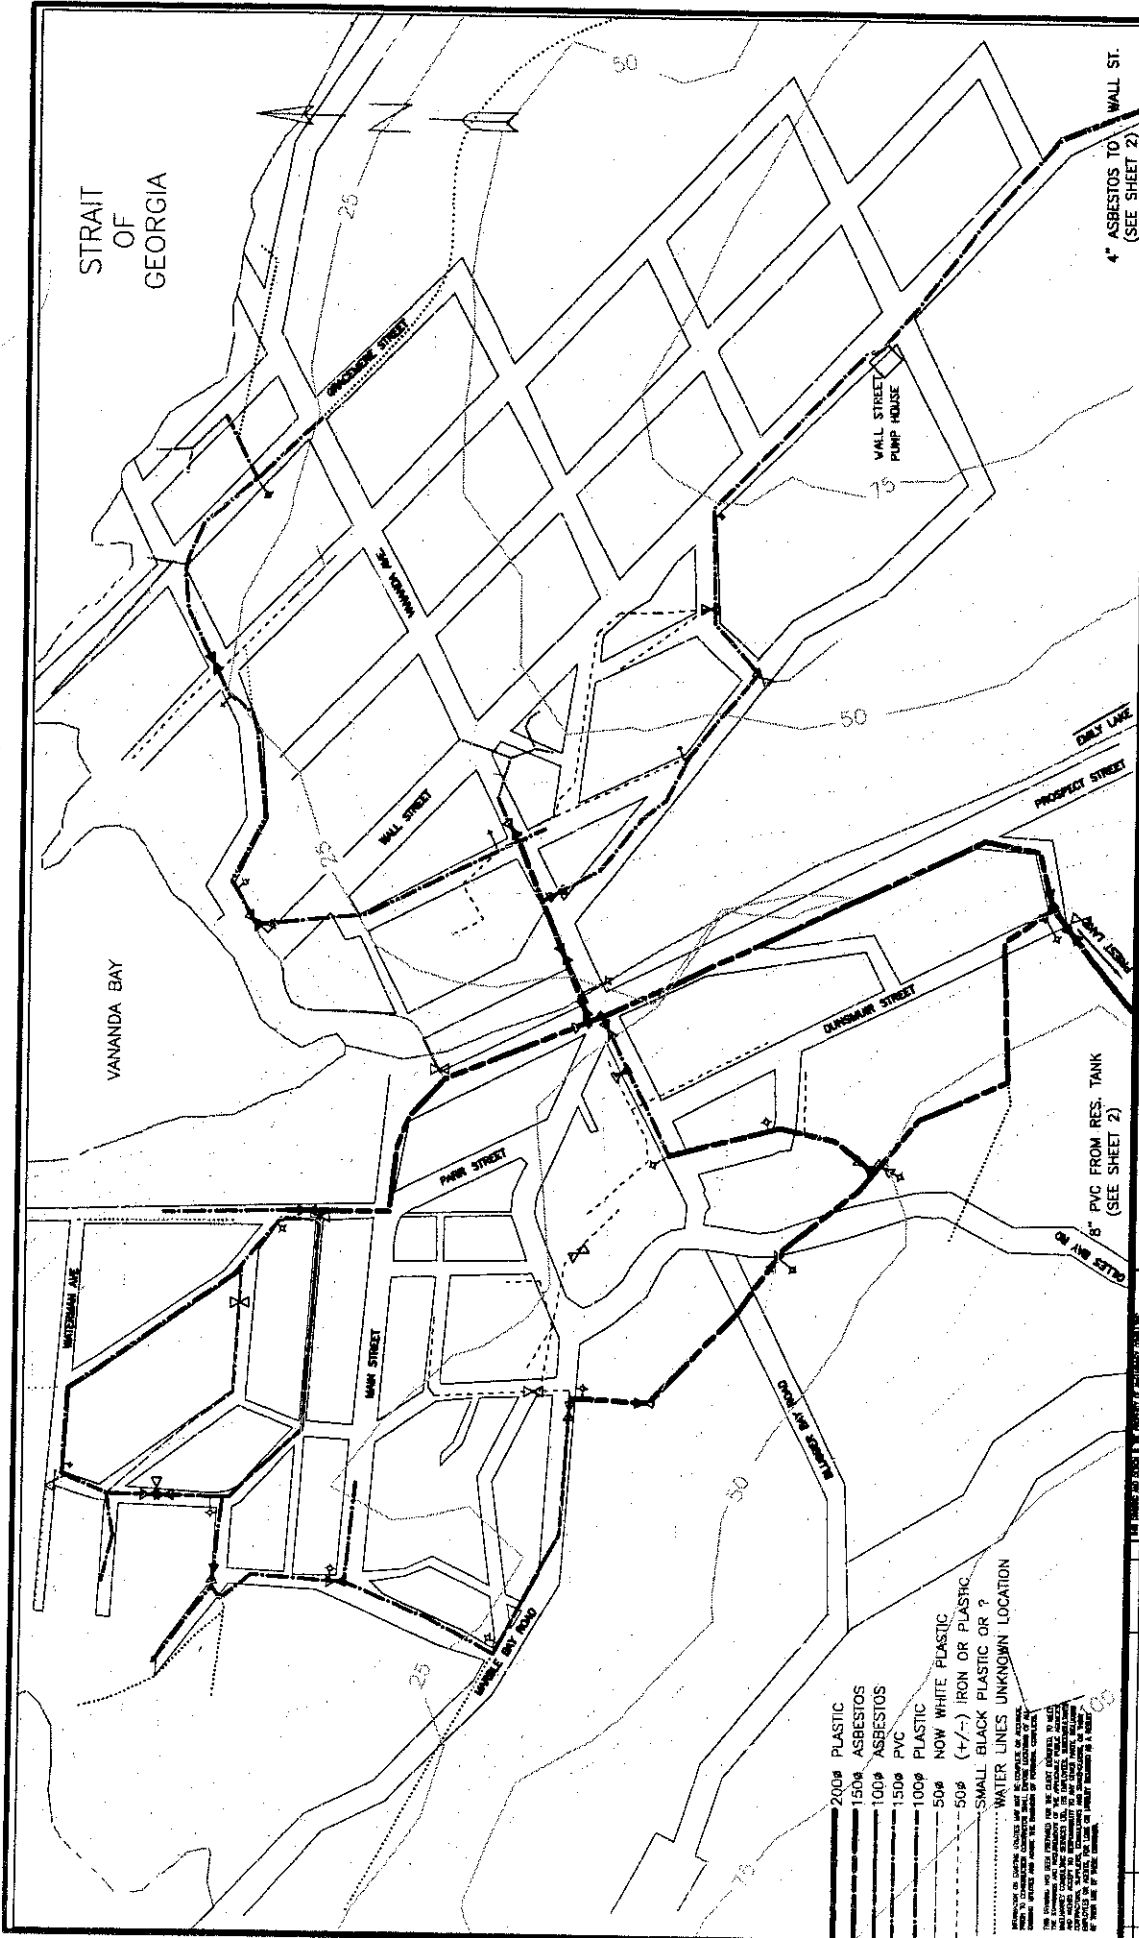
The system as outlined in Figures 1 and 2, consists of the distribution reservoir (Approximate elevation of 110 m, 1976 wood-stave construction, 204 m³), and a water transmission main (200mm diameter PVC) supplying a piping network that ranges in elevation from 5m to 80m above sea level. The following table summarizes piping and isolation valves of the distribution system, and the system includes the Wall Street booster pumping station and 21 hydrants as well.
