ZONSCAN NET Leak Detection Report

Van Anda Improvement District, BC Jan 7, 2025 (Report created on Jan 23, 2025, 1:15:42 PM)

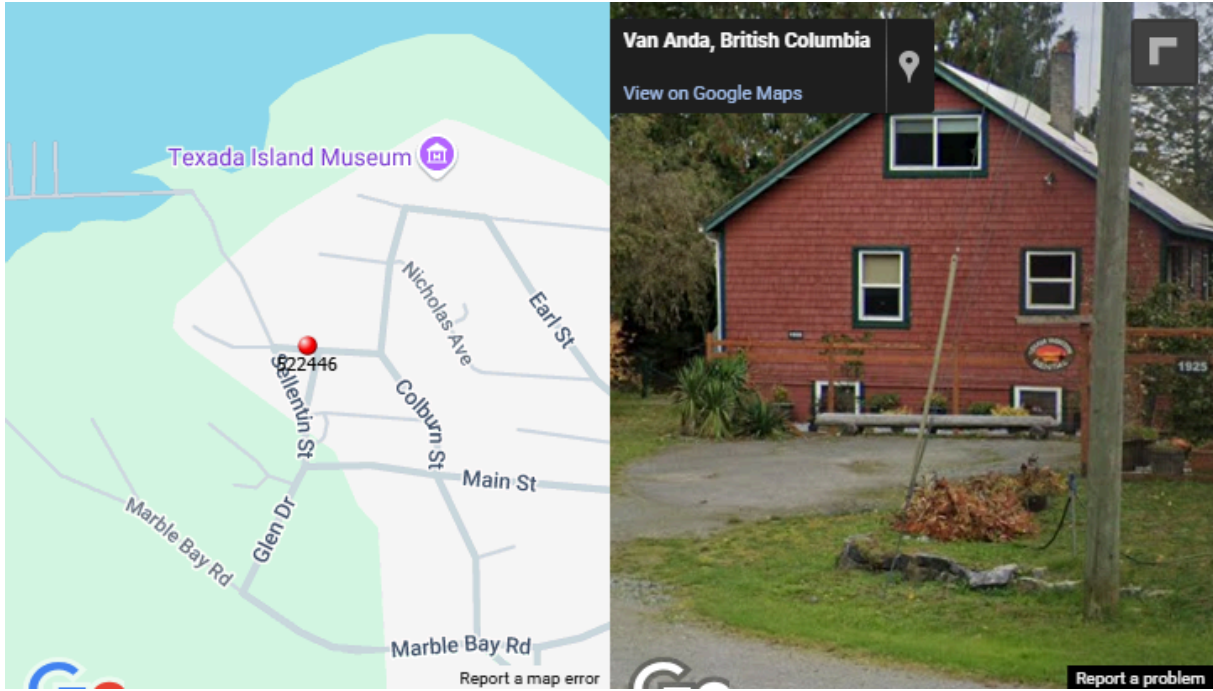
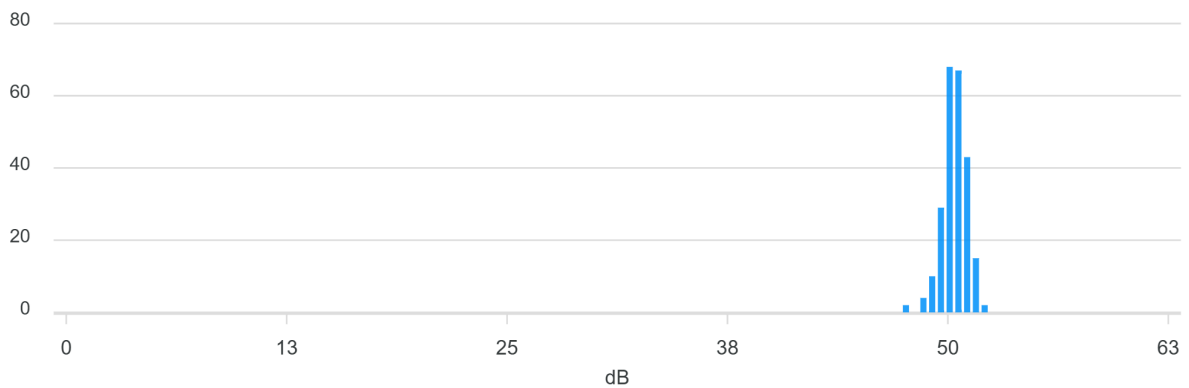
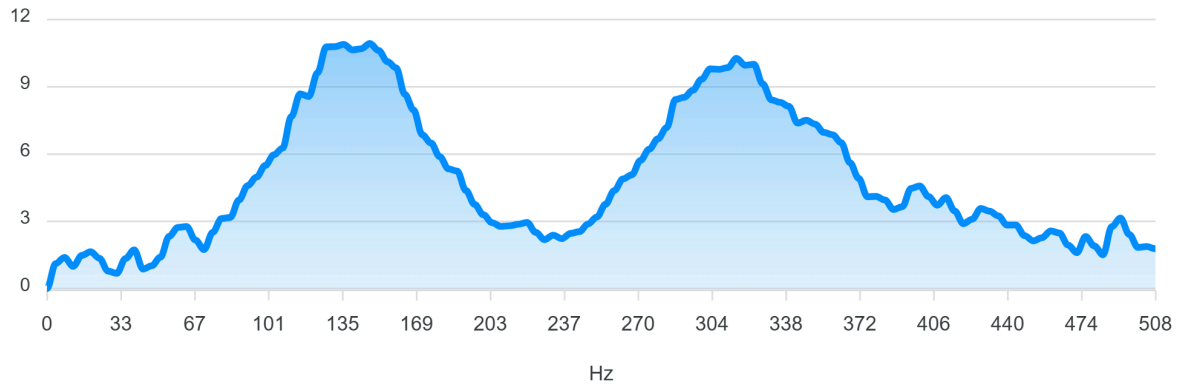
Logger: 522446

Leak Score	Location	Logger	Min. Noise	Env. Noise	Comments
96	1986 Nicholas Ave, 49.758949°, -124.560357°	522446	48.0		201 Sturt Bay Rd

Ground microphoning found significant noise 26' - 30' from the service box (28' being the loudest noise). The noise was heard 4' 4" out from the fence post. - The left service connection should be dug up, for a leak suspected to be on the utility side.

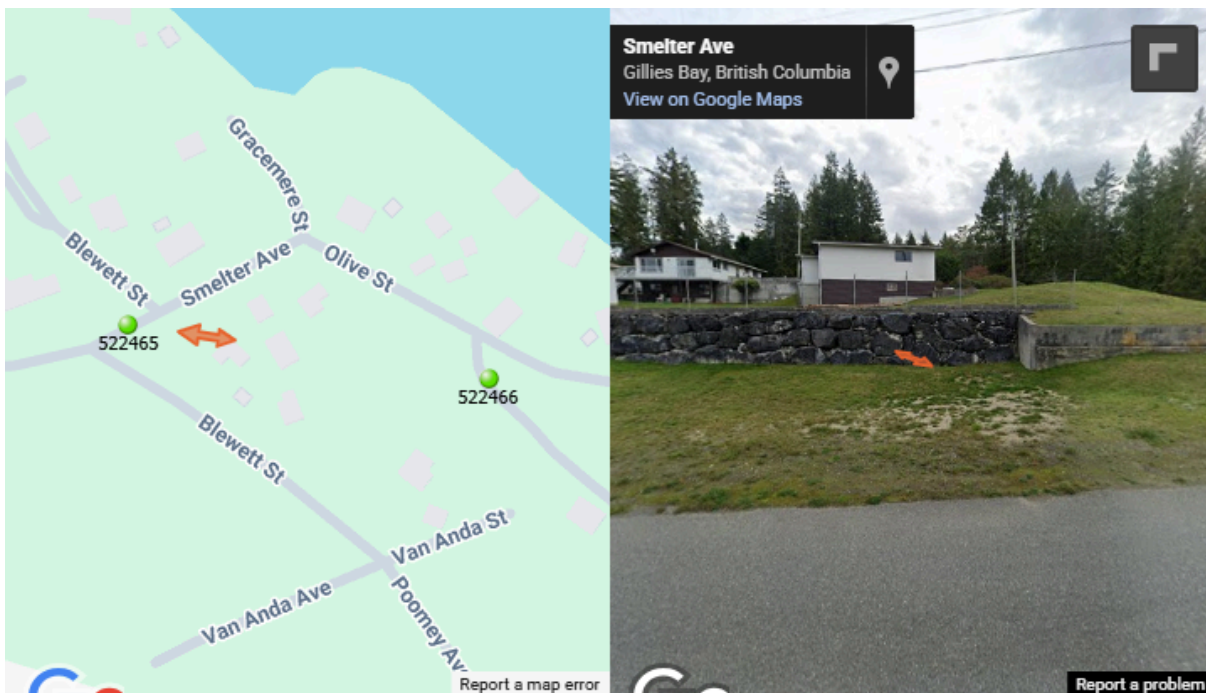
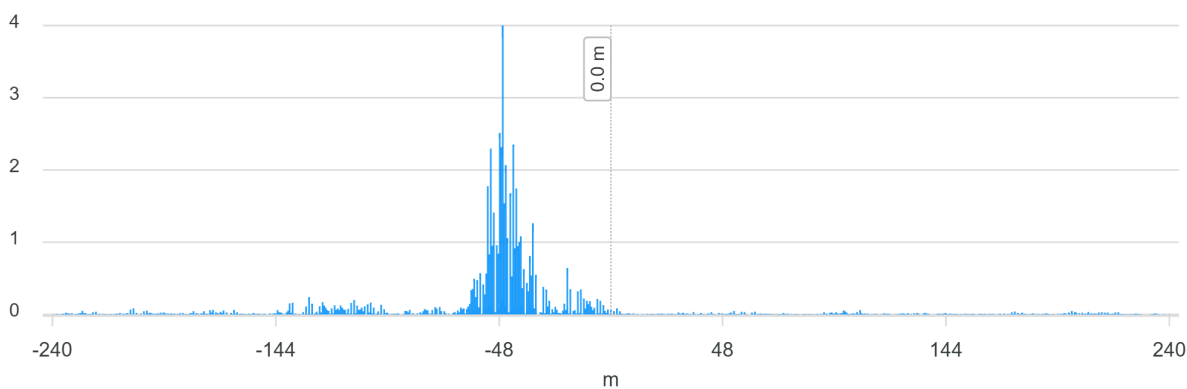
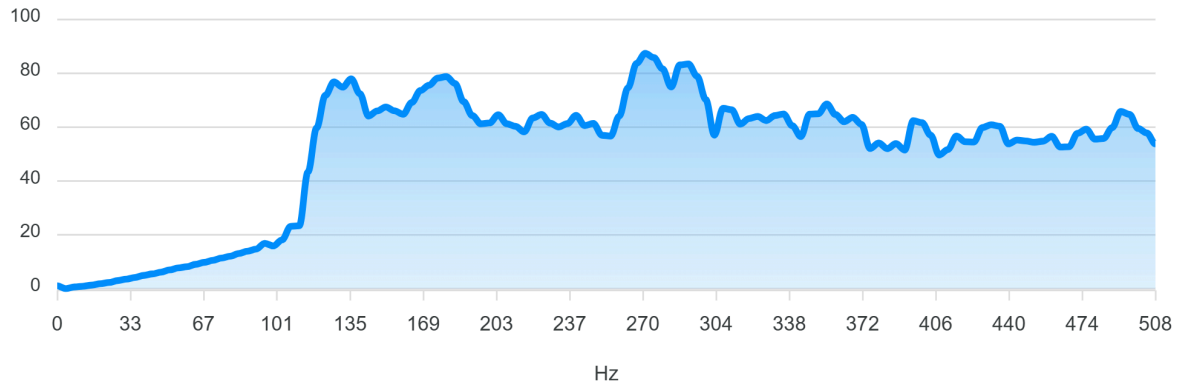
Correlation: 522465 - 522466

Quality	Location	Logger 1	Logger 2	Dist. L1	Dist. L2	Center Dist.	Pipe Len.	Comments
90.0	5270 Blewett St, 49.758702° -124.549738°	522465	522466	37.1 m	129.9 m	-46.4 m	167.0 m

A watermain leak is suspected to be located in front of 24166 Smelter Ave. Specifically, in the area of the previous repair where the asphalt is cracked. In addition to this leak, the service connection to 24166 is currently shutoff, and leaks if it not in the current position. On the customers side, it is currently being held on by two hose clamps.

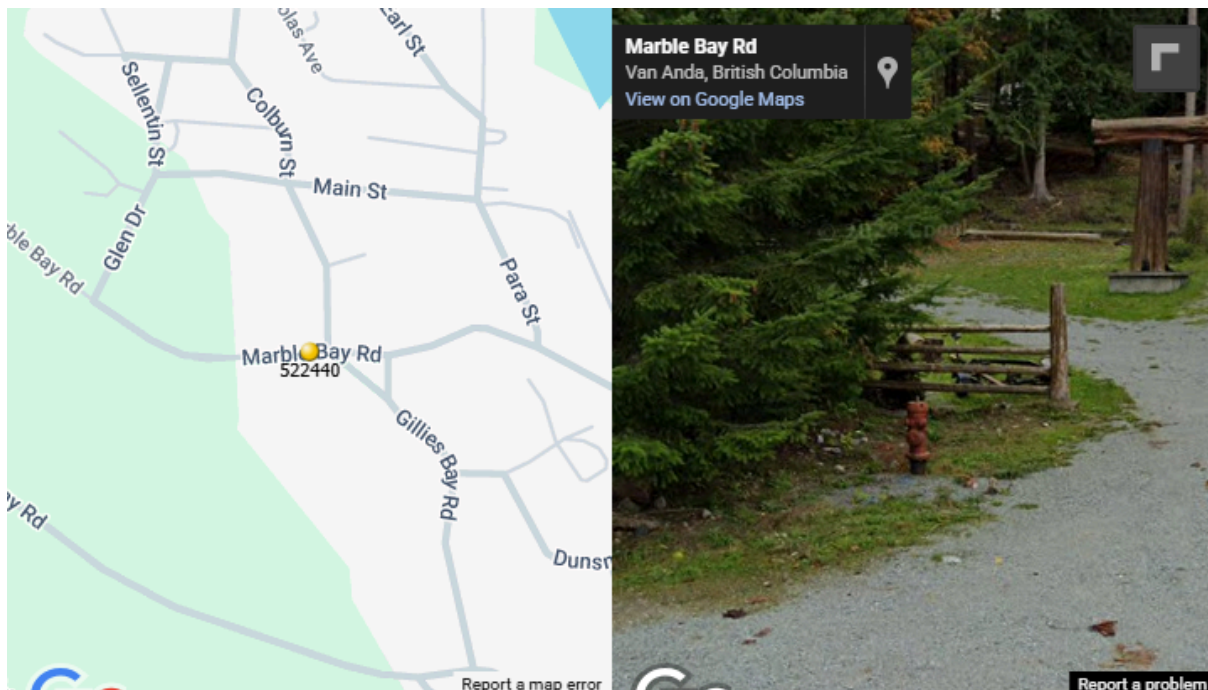
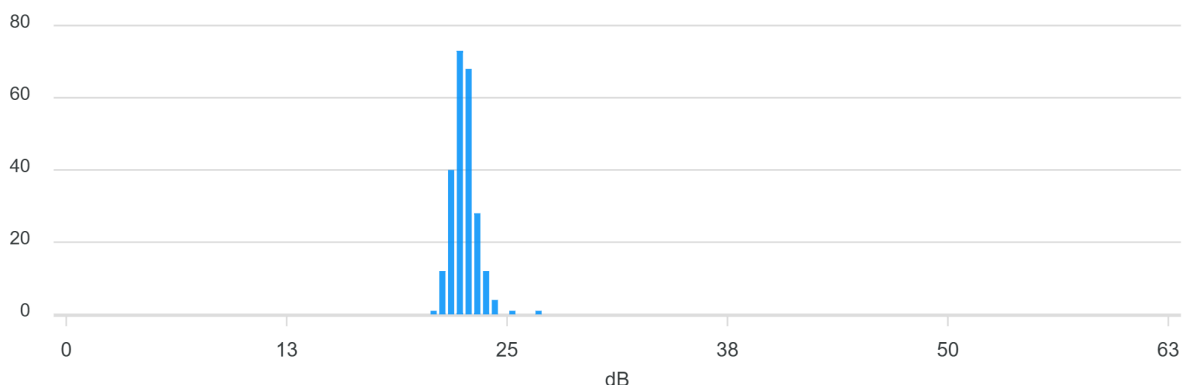
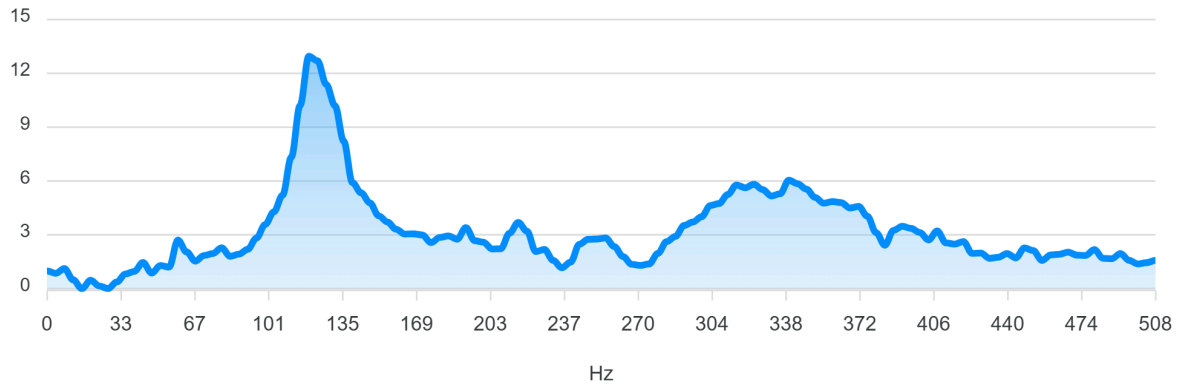
Logger: 522440

Leak Score	Location	Logger	Min. Noise	Env. Noise	Comments
49	1988 Marble Bay Rd, 49.756495°, -124.558411°	522440	21.0

The first hydrant across the road from Mary Mary's Café is leaking when in the closed position.

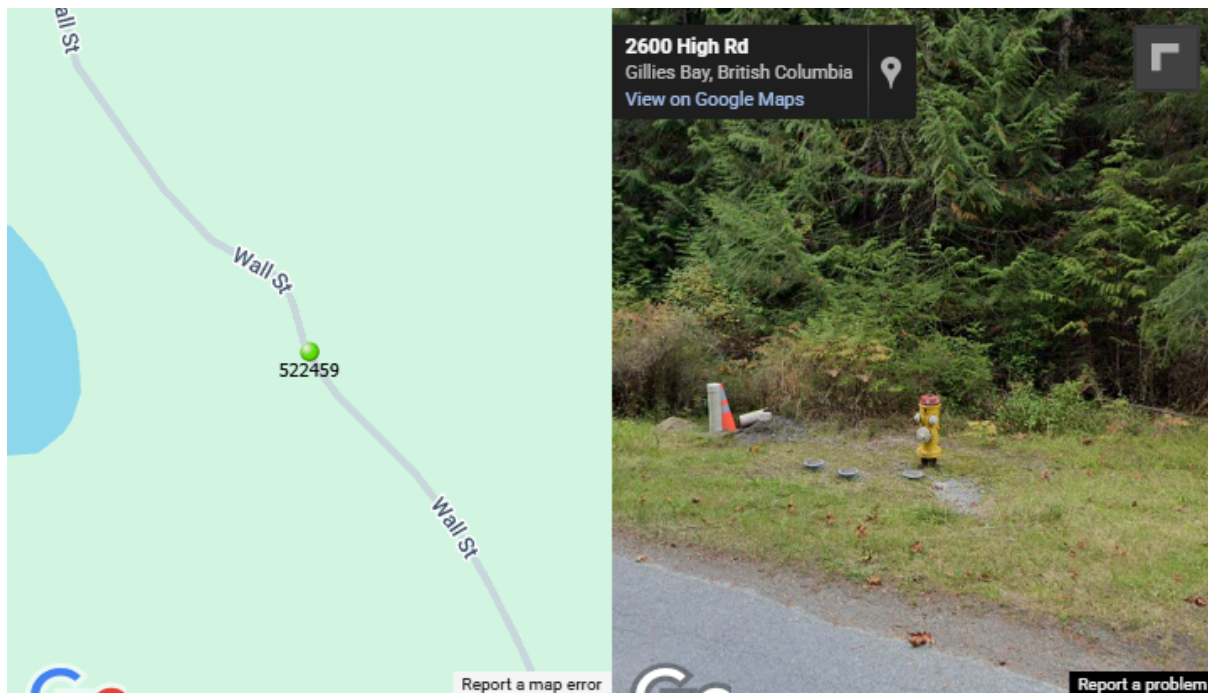
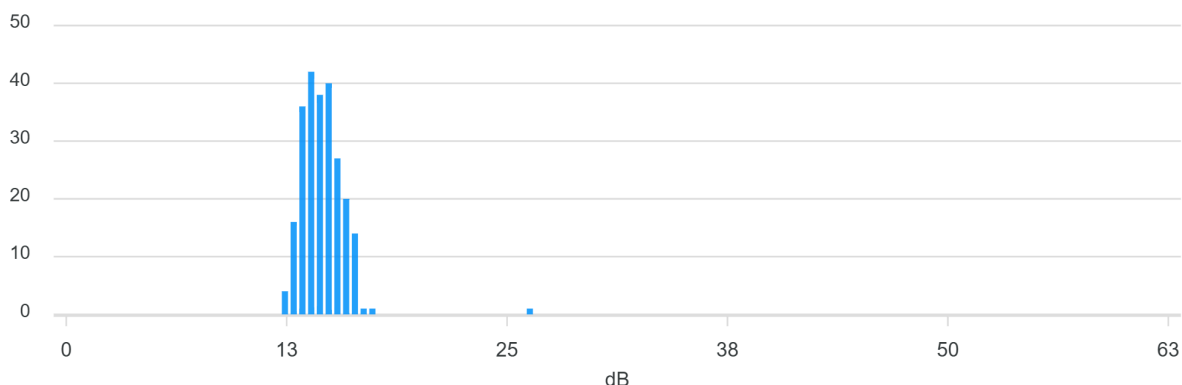
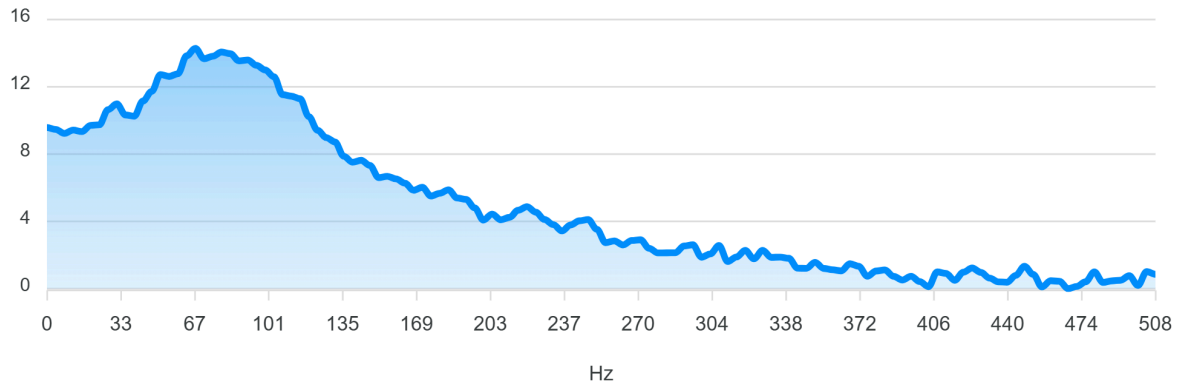
Logger: 522459

Leak Score	Location	Logger	Min. Noise	Env. Noise	Comments
9	High Rd, 49.745848°, -124.540034°	522459	12.5

The fire hydrant is confirmed to be leaking when in the closed position.

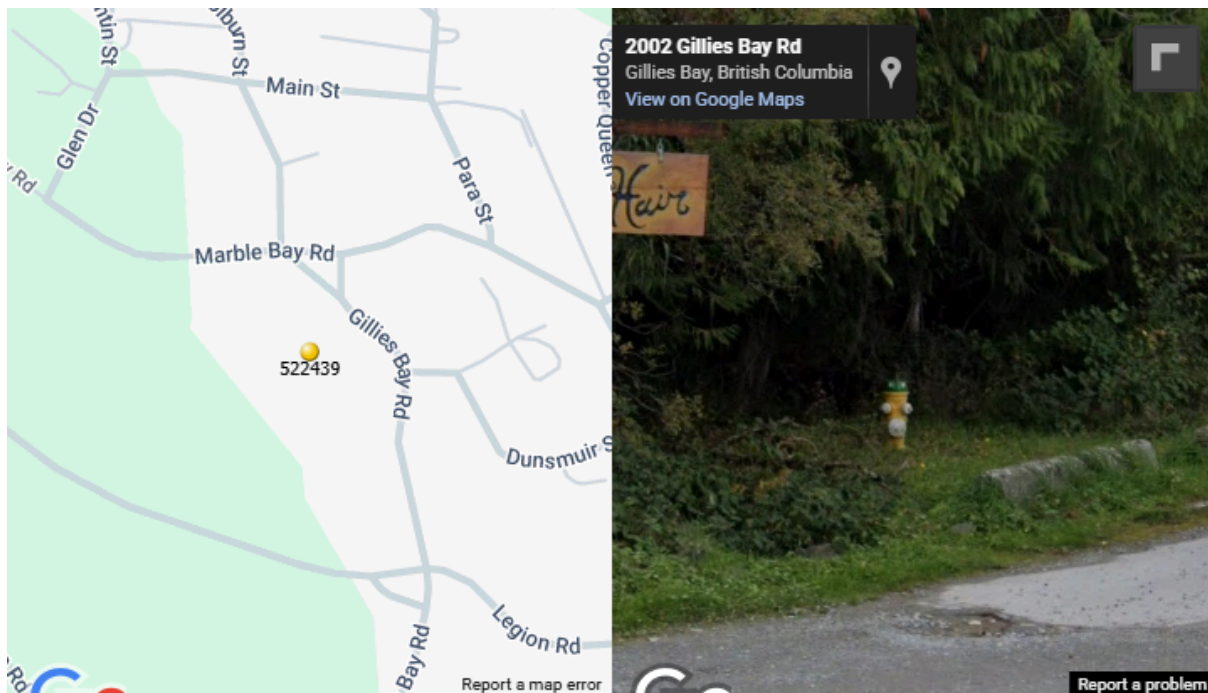
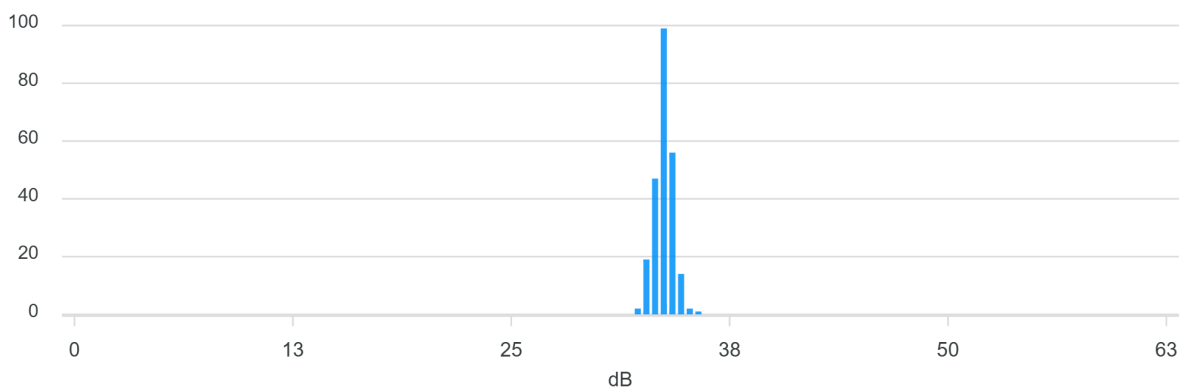
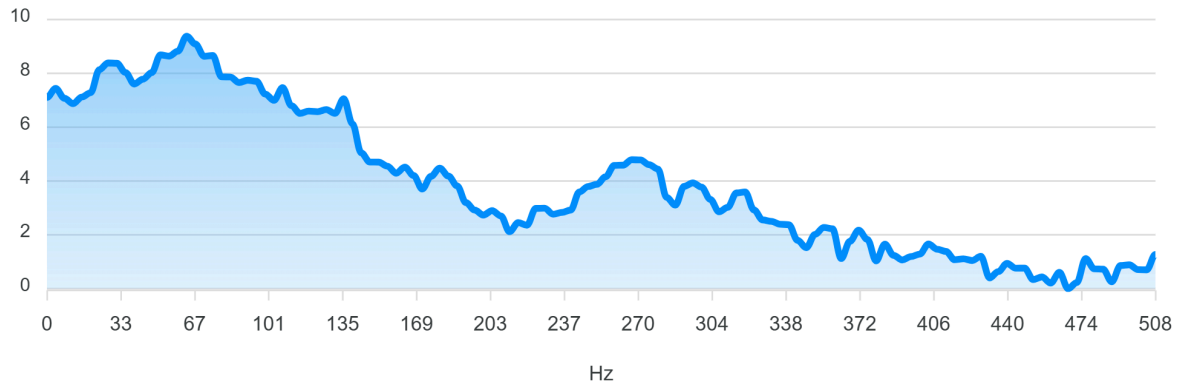
Logger: 522439

Leak Score	Location	Logger	Min. Noise	Env. Noise	Comments
53	1108 Gillies Bay Rd, 49.755673°, -124.557811°	522439	32.5

The fire hydrant on the corner of the parking lot to the Texada Island Inn, is confirmed to be leaking when in the closed position.
