**WATERSHED ASSESSMENT (CWAP) FOR
PRIEST LAKE, TEXADA ISLAND, BC**

0801-00-81528

FINAL REPORT

MINISTRY OF FORESTS, SUNSHINE COAST FOREST DISTRICT
Powell River, B.C.

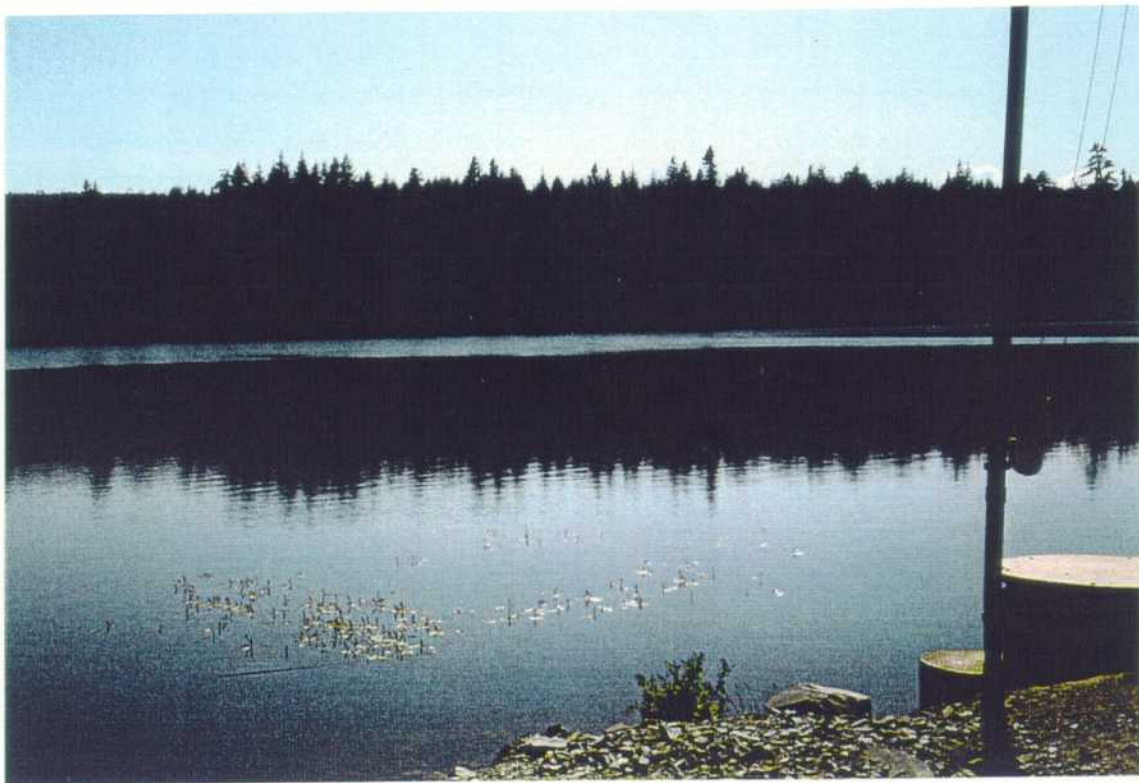
Photo 1 – Priest Lake, view from water intake (June, 2000)

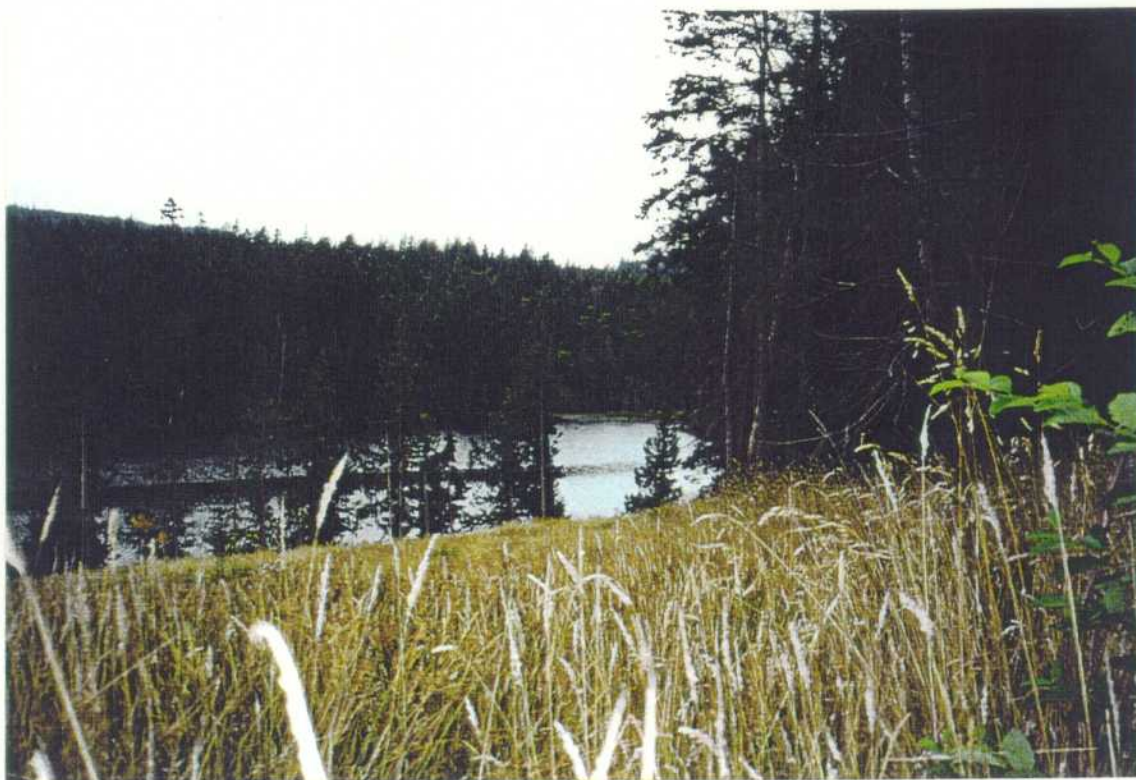
Photo 2 – Priest Lake, view from proposed cutblock (Block 403).

Grassy area is cleared private land (July, 2000)
