Ministry of  
Transportation  
and Infrastructure

# Texada Island Drainage Study

Final Report

January 2024

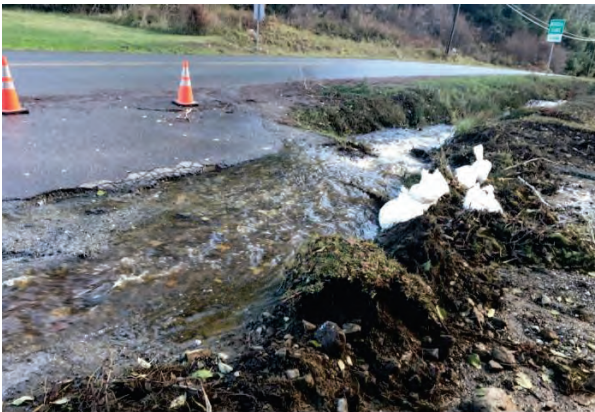
- A new crossing culvert under Airport Road was installed by the MoTI’s maintenance contractor, Capilano Highways, in response to flooding in November 2021 with a noted deficiency of crossing culverts along Airport Road.
- An additional driveway culvert was installed under the driveway to the tennis court at Gillies Bay Road south of the intersection with Airport Road (see [Photo 3](#)) in response to the flooding in November 2021.

PHOTO 3: AREA 4 - OVERFLOW OF DRIVEWAY CULVERT (MOTI)

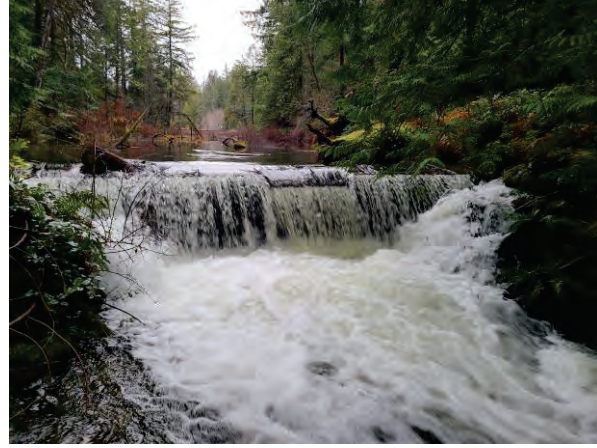
PHOTO 6: PRIEST LAKE WEIR DURING WET PERIOD (VAN ANDA IMROVEMENT DISTRICT)

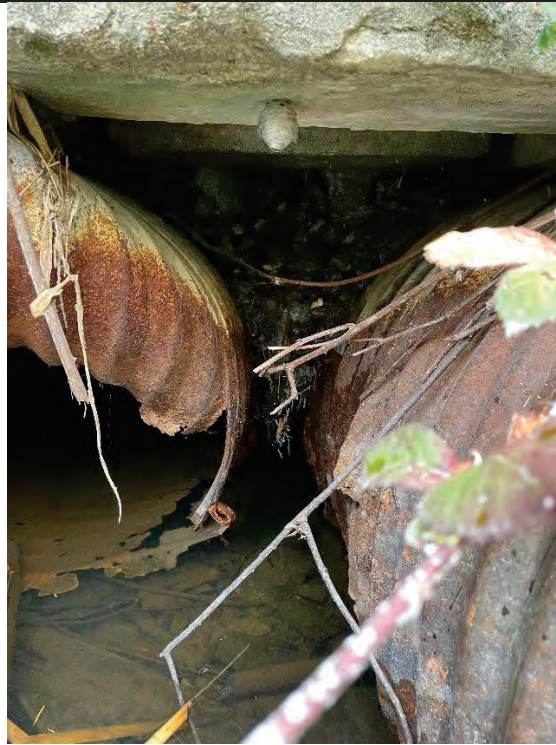
Culvert Inlet: CRB sitting on culverts, large cavity visible between twin pipes

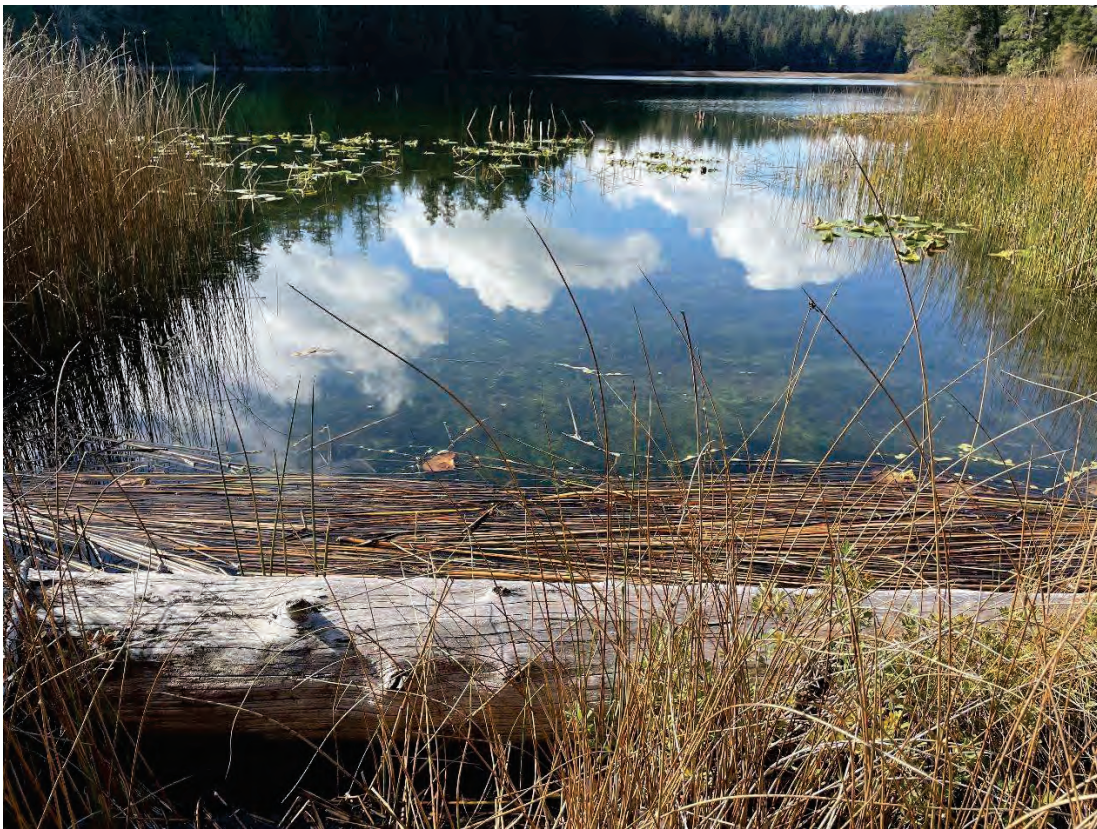
Upstream Channel: Culvert acts as outlet of Priest Lake crossing Priest Lake Rd & Gillies Bay Rd

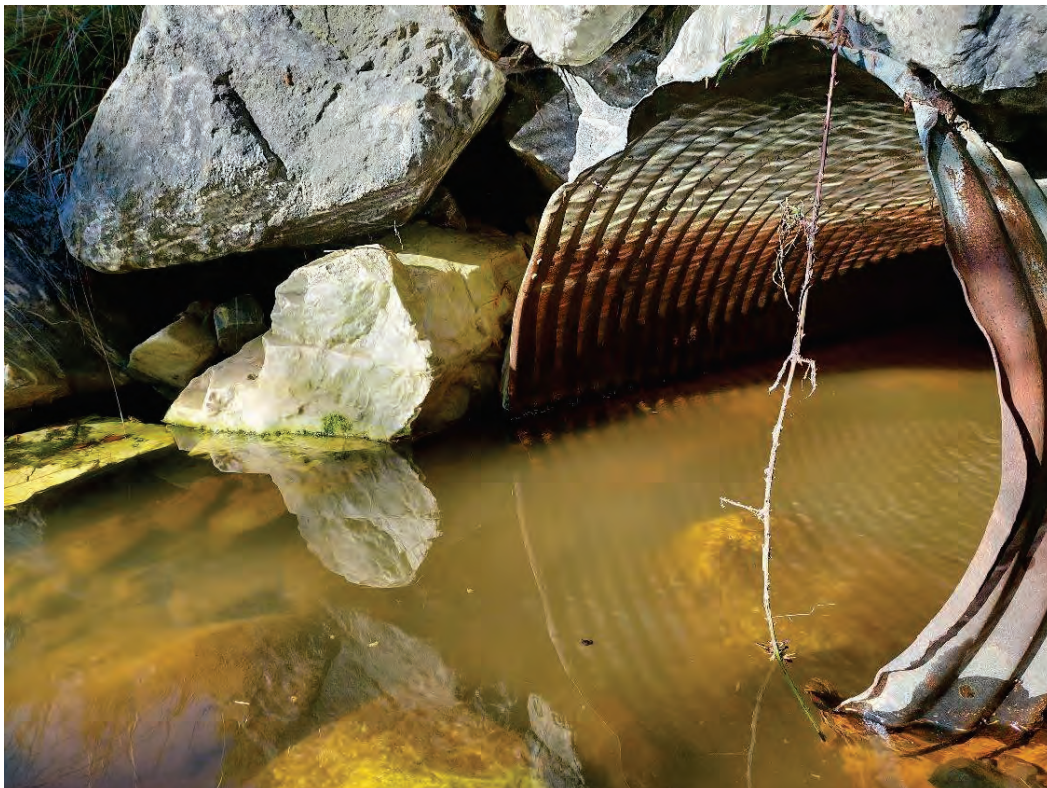
Culvert Outlet: 1200mm CSP pipe with riprap headwall

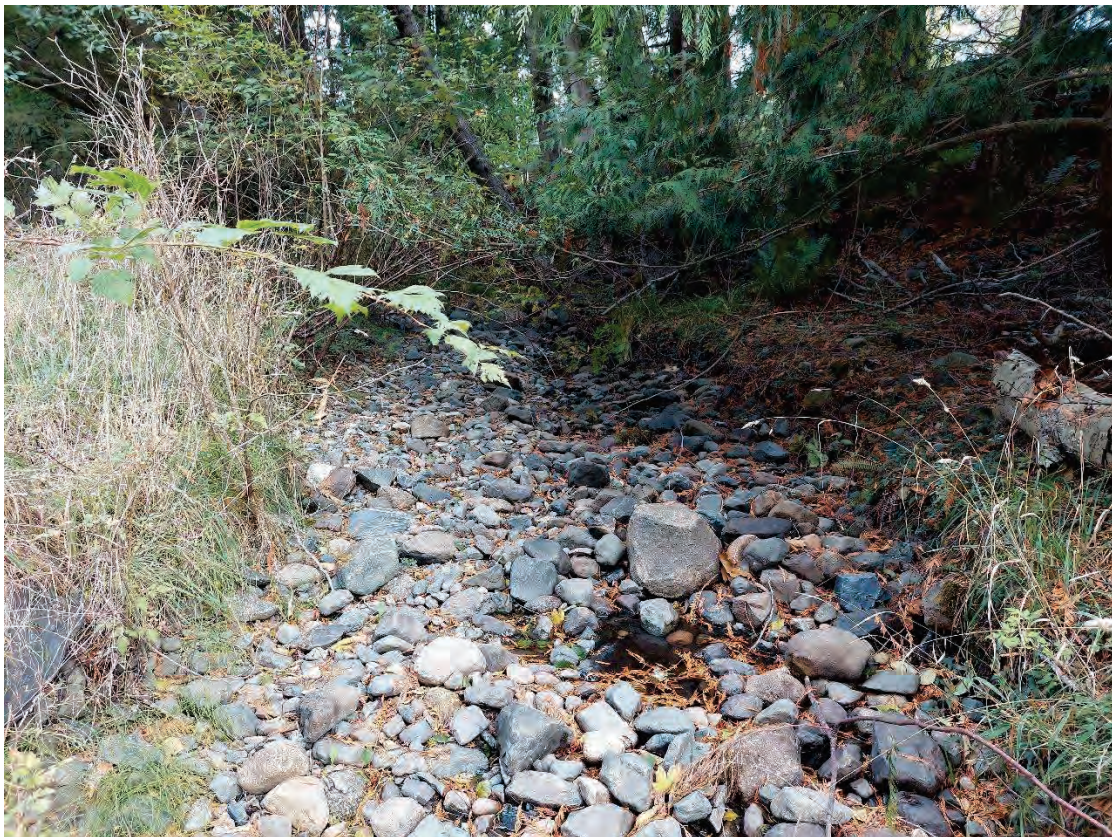
Upstream Channel facing US: Staaf Creek with minimal flow visible

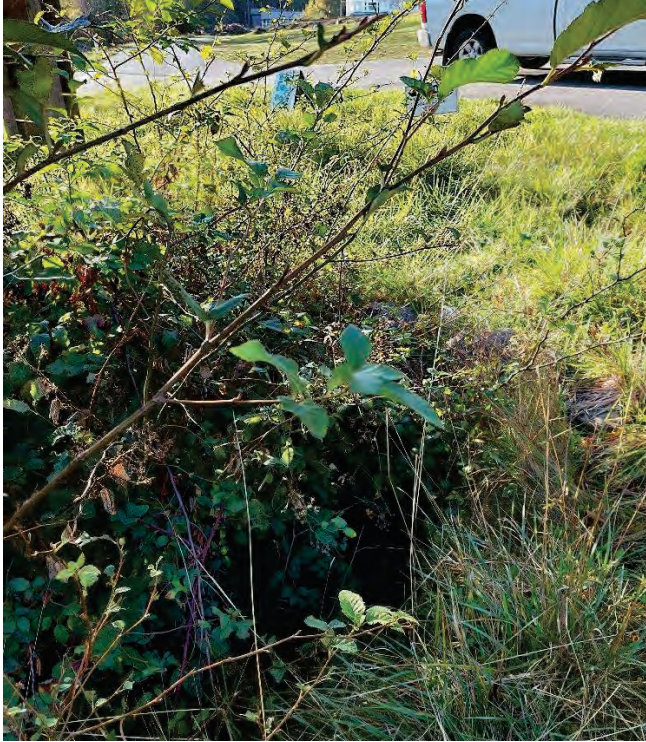
AREA 4 SANDERSON RD: OVERGROWN ROADSIDE DITCH

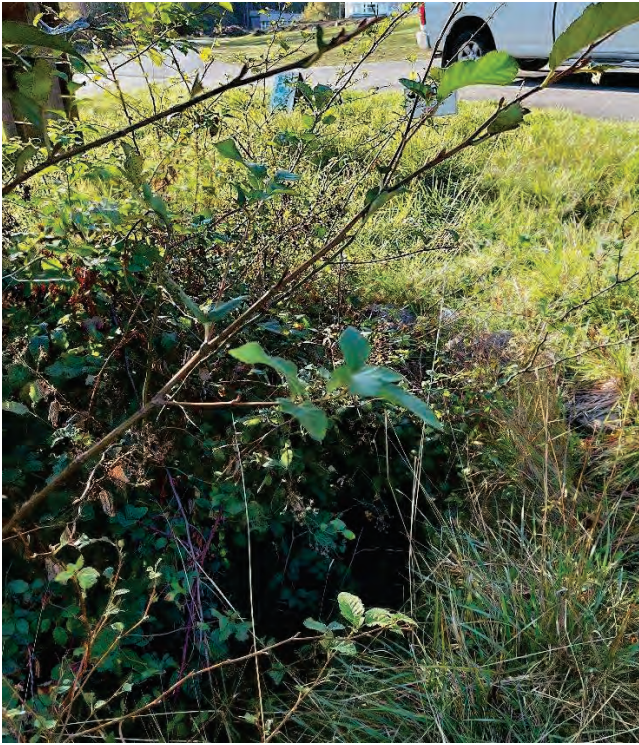
CULVERT 7 (2258625) OUTLET: OVERGROWN ROADSIDE DITCH

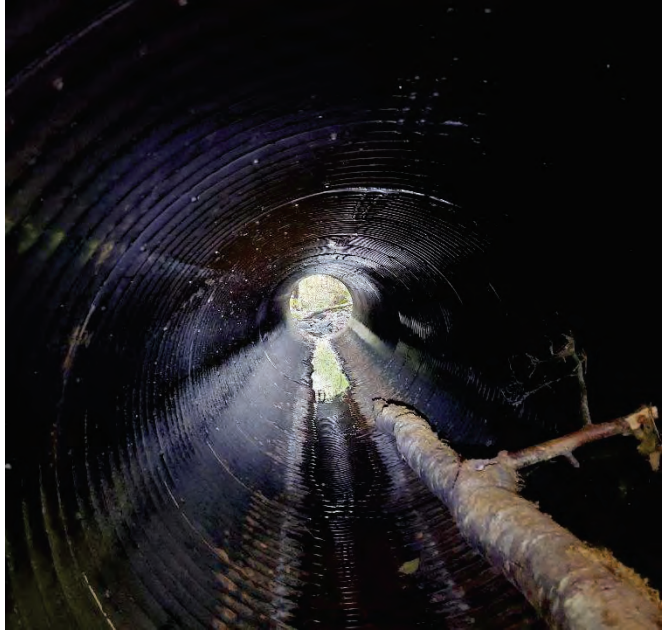
CULVERT 9 (2256424) INTERIOR: PIPE COATING MOSTLY INTACT

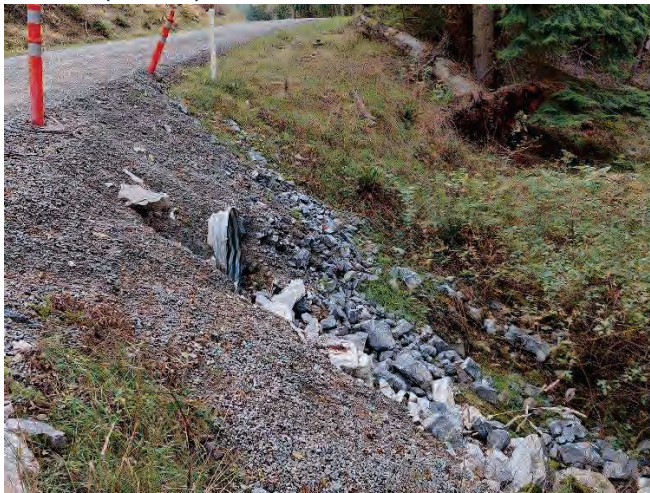
CULVERT 11 (2254788) OUTLET: ERODING ROAD EMBANKMENT AT OUTLET

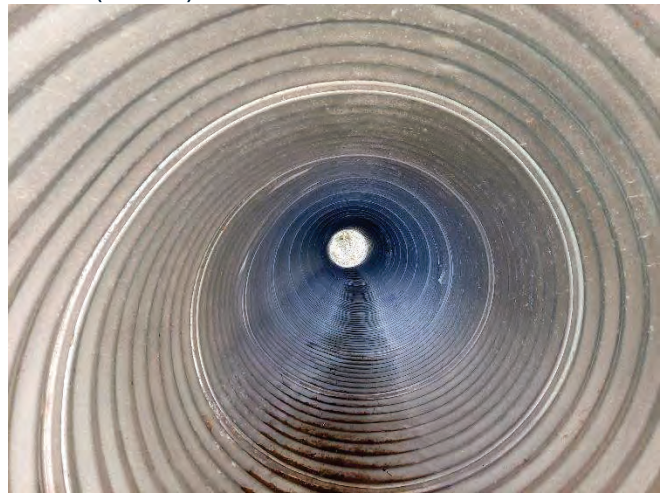
CULVERT 11 (2254788) INTERIOR: GOOD PIPE CONDITION

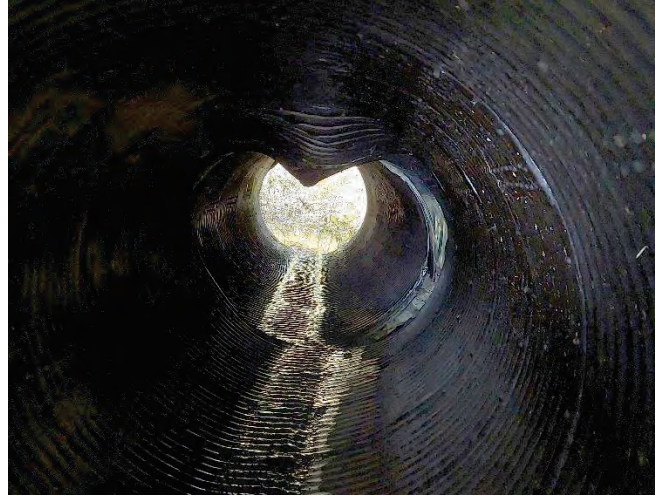
CULVERT 12 (2255061) INLET: INLET BEND
