ZONSCAN NET Leak Detection Report

Van Anda Improvement District, BC Jan 7, 2025 (Report created on Jan 23, 2025, 1:15:42 PM)

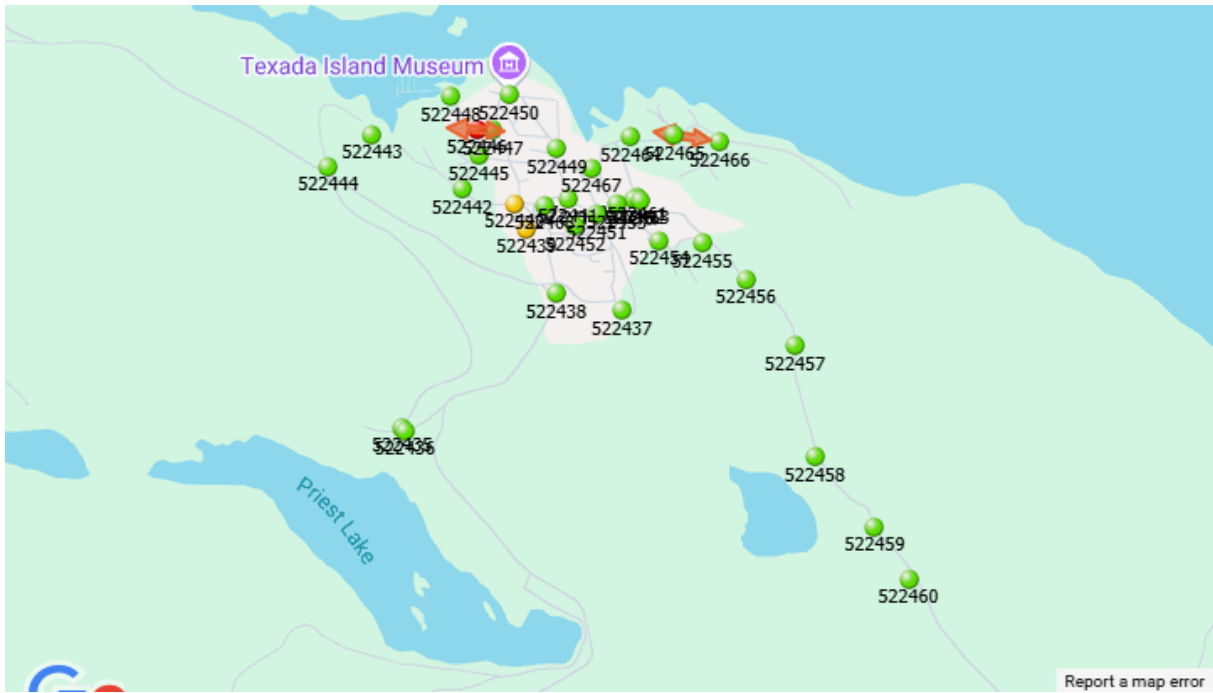
Quality	Location	Logger 1	Logger 2	Dist. L1	Dist. L2	Center Dist.	Pipe Len.	Comments
100.0	1986 Nicholas Ave, 49.758947° -124.560302°	522446	522447	4.0 m	55.6 m	-25.8 m	59.5 m	
90.0	5270 Blewett St, 49.758702° -124.549738°	522465	522466	37.1 m	129.9 m	-46.4 m	167.0 m
