Ministry of  
Transportation  
and Infrastructure

# Texada Island Drainage Study

Final Report

January 2024

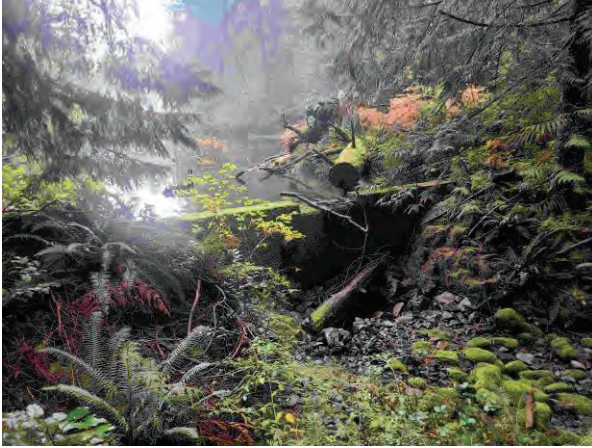
PHOTO 5: PRIEST LAKE WEIR DURING DRY PERIOD (VAN ANDA IMROVEMENT DISTRICT)

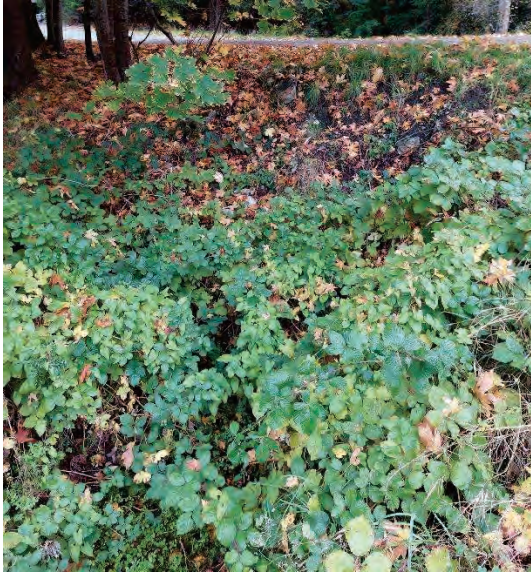
AREA 2 MARBLE RD: 600MM WOOD STAVE CULVERT (3442931) INLET

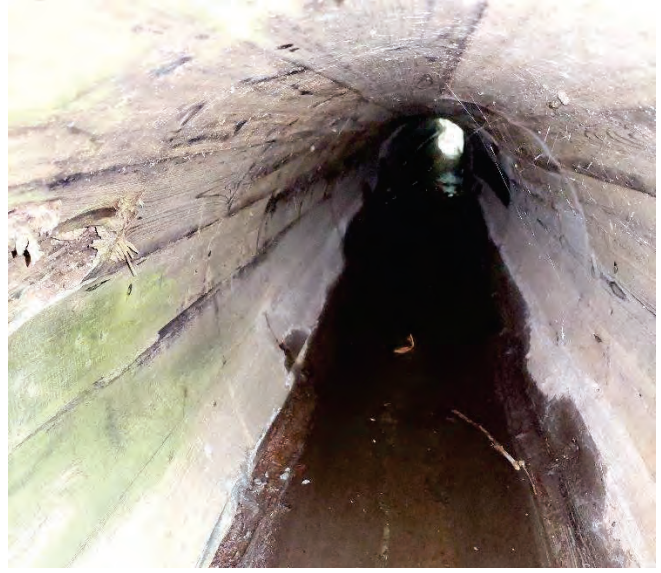
AREA 2 MARBLE RD: WOOD STAVE CULVERT (3442931) INTERIOR

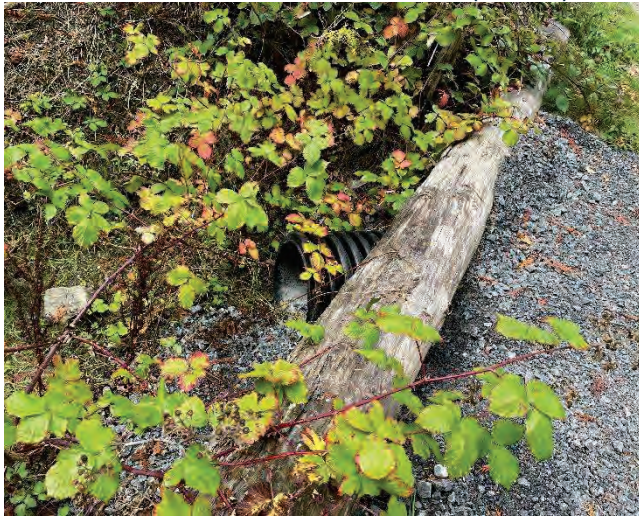
AREA 2 MARBLE RD: 450MM HDPE INLET, EXTENDED FROM CSP

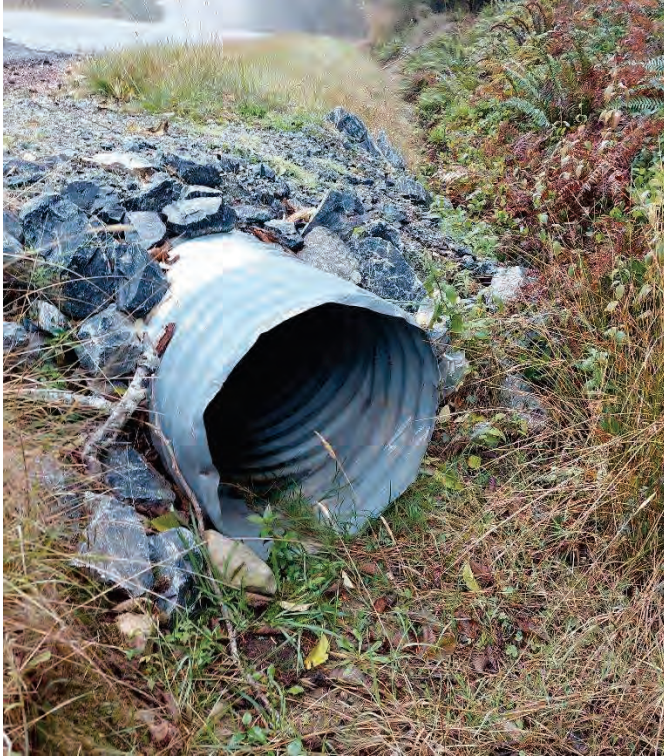
AREA 4 AIRPORT RD: NEW CULVERT INLET WITH IMPROVISED CHECK DAM INSIDE ROADSIDE DITCH

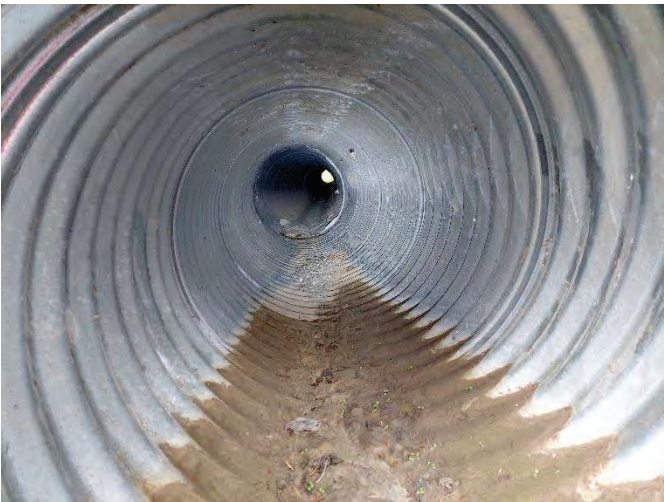
- The culvert pipe alignment is bent with minor pipe joint separation visible. The overall culvert condition appeared to be fair.
- A 300 mm CSP culvert (CHRIS: 2258675) was inspected at the water tank driveway with a heavily corroded pipe invert and in poor condition.

AREA 4 AIRPORT RD: NEW CULVERT INTERIOR FROM OUTLET, VISIBLE PIPE JOINT SEPARATION AND MISALIGNED CULVERT

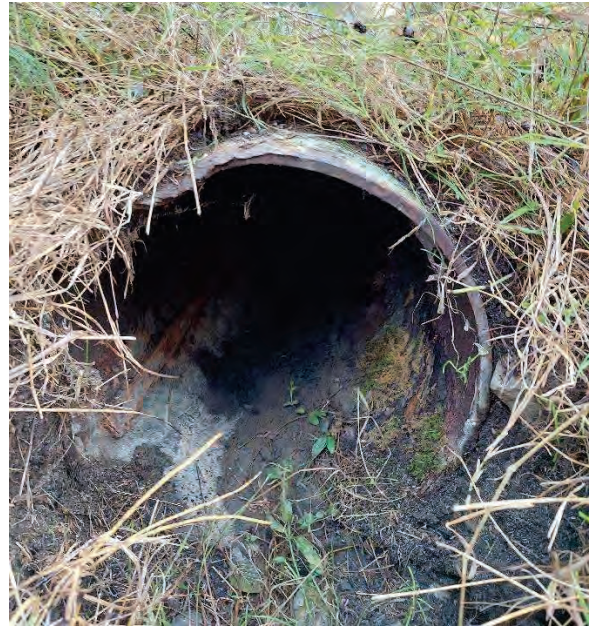
- A 450mm DI culvert was inspected south of the water tank with only surficial corrosion and in overall fair condition (49.682369°N, 124.490133°W).
- The western roadside ditch along Airport Road showed multiple locations with visible erosion and scour, likely from the high flows in the ditch due to the high slope between the water tank and Pine Street.

AREA 4 AIRPORT RD: 450MM DI CULVERT INLET

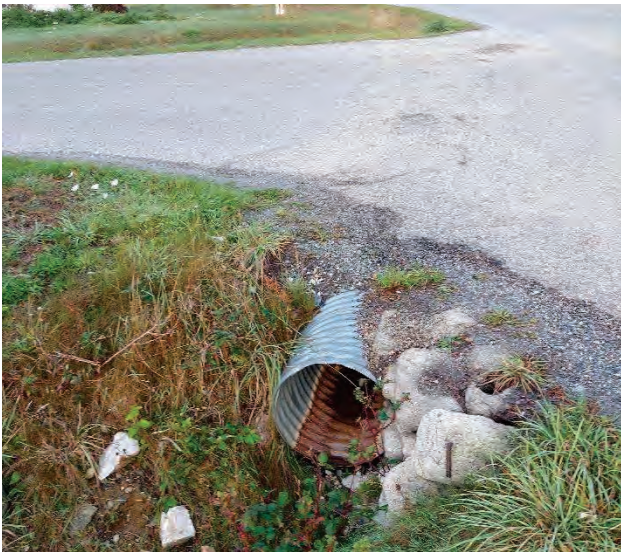
- A 600 mm CSP culvert (CHRIS 2256637) crossing under Pine Street was inspected with visible corrosion of the pipe invert and a damaged inlet but overall, in a fair condition.

AREA 4 AIRPORT RD: 600MM CSP CULVERT (2256637) UNDER PINE ST OUTLET

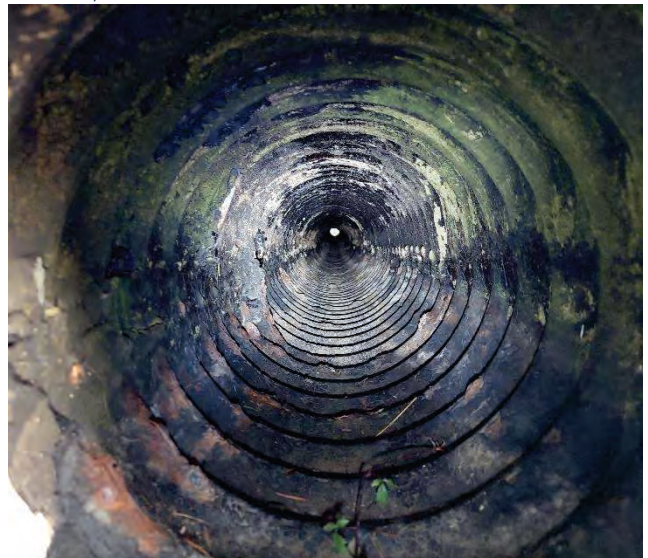
- A 300 mm CSP culvert (CHRIS: 2256020) crossing under Airport Road and conveying the roadside ditch flows along the westside of Gillies Bay Road. The culvert showed localized corrosion but appeared to be in fair condition.

AREA 4 AIRPORT RD: 300MM CSP CROSS CULVERT (2256020) UNDER AIRPORT RD AT GILLIES BAY RD

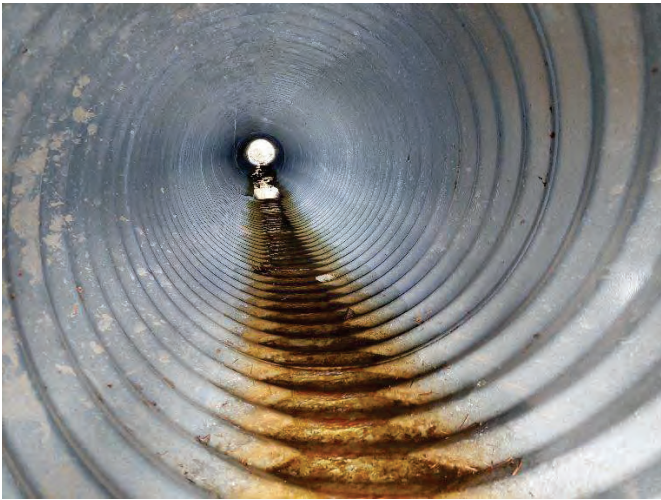
- The western pipe appeared to be recently installed and in good condition. The pipe appeared not be fully aligned with the ditch.
  - The eastern pipe appeared to be older with significant corrosion and loss of material and in poor condition.

AREA 4 GILLIES BAY RD: NEW WESTERN 600MM CSP CULVERT INTERIOR

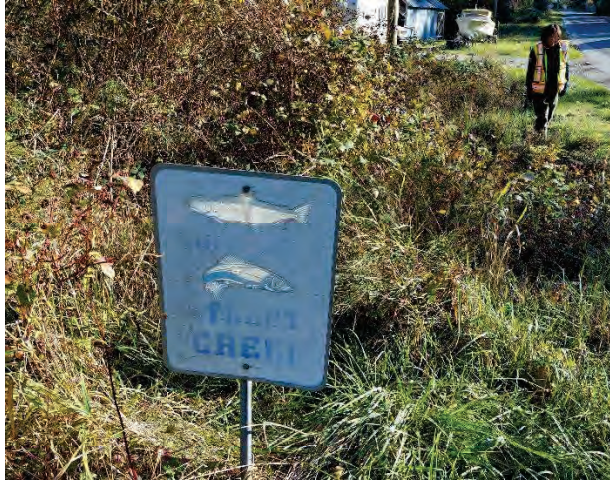
AREA 5 GILLIES BAY: ARCH PIPE CULVERT (2256032) INLET OVERGROWN

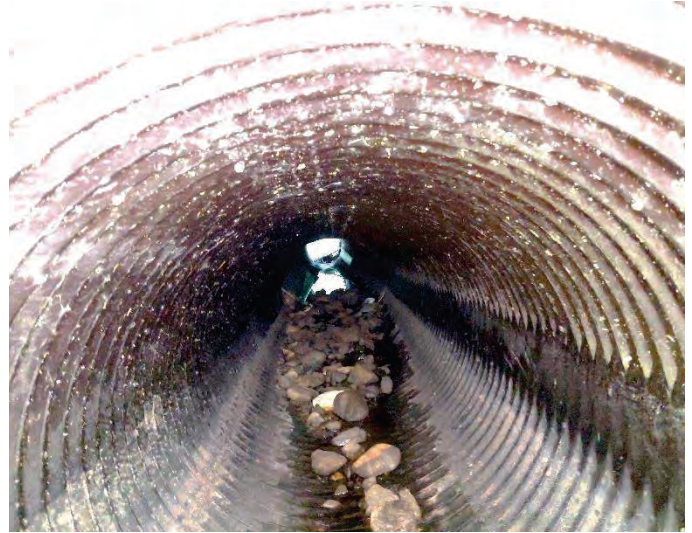
CULVERT 6 (2256019) INTERIOR: PIPE JOINT SEPARATION AND ROCK DEBRIS
